The Timurid Gateway – Reconstruction and Conservation

Preceding Measures

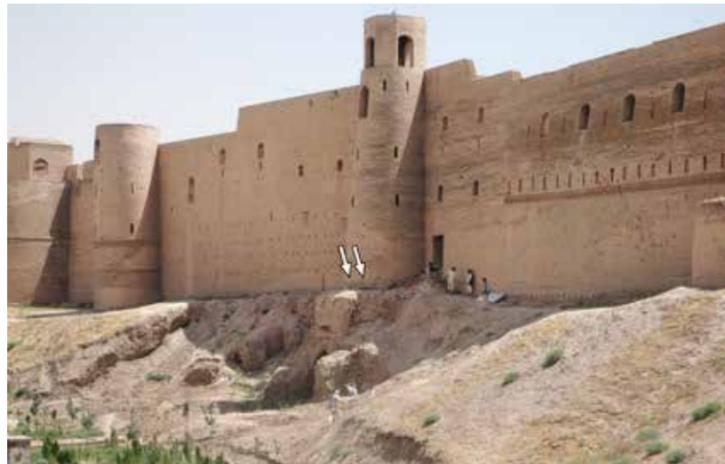
cracks had appeared for the first time, the necessity to stabilise the area for static reasons was obvious. The weight of the mighty citadel wall and the difference in height between its position and that of the surrounding city undoubtedly represent a considerable threat to the stability of the entire structure. Therefore, already from the first days of the excavation onwards, protective measures were developed within the area of excavation as well as in its surroundings.

⁷¹ The cracks were documented and for further observation of this development controlled by means of plaster seals.

Fig. 560 The gateway area prior to the 2008 excavations, localisation of the cracks in Tower XVIII; from west

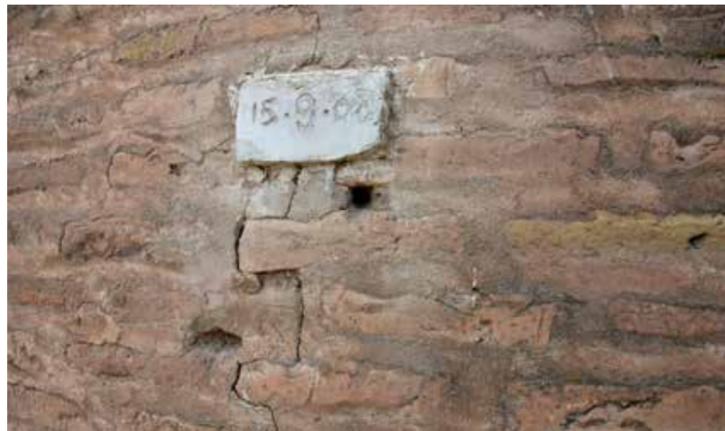
Fig. 561 Tower XVIII, above the gateway, setting cracks and plaster seal of 2008

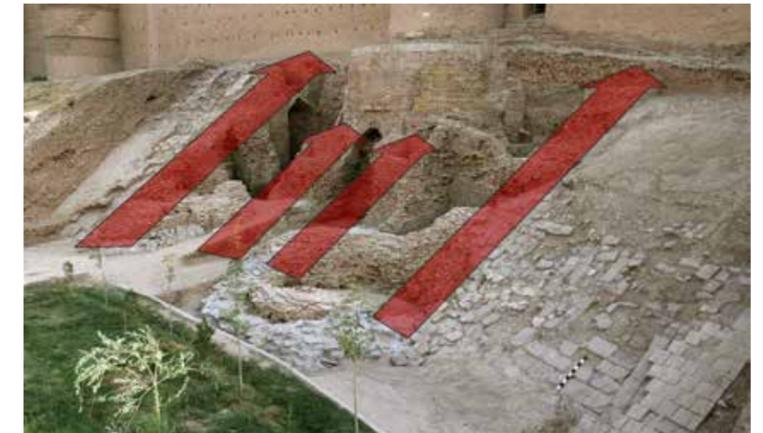
Fig. 562 Gateway at the end of the excavation 2008, schematic display of the necessary supportive system (cp. Fig. 563)

Composition and structure of construction principally follow the prerequisites of statics. The expert assessment called for four massive buttresses, leading from the present ambient level up towards the citadel wall (Figs. 562; 563). In their architectural implementation these four buttresses correspond to the two outer walls as well as the two north-south oriented inner walls of the gate complex (Fig. 563). By means of a three-dimensional visualisation (Fig. 564) and

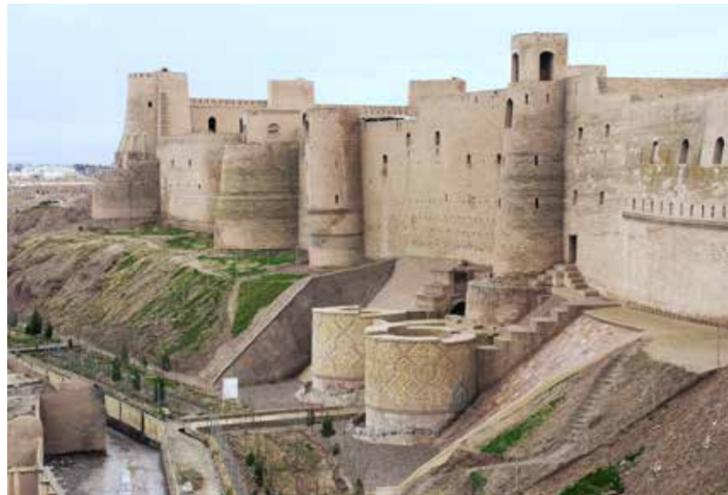
Fig. 565 Completed supporting structure, October 2009; from west

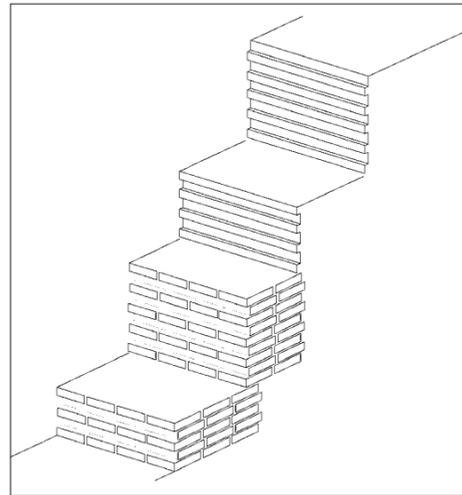
Fig. 566 Schematic view of the implementation of the outer buttresses on the ascending citadel slope, detail, layout of the vertical surfaces as reconstructed only in part

of the towers and enclosure walls as well as to the exact level of vaults and roofs. In order to exercise their static function the walls had to be massively reinforced; and since they could not be widened any further, the only possibility was to raise the height. For the reconstruction this implied that from a certain height upwards passageways had to be vaulted and ceiling or roof constructions had to be indicated or implemented. A largely well-founded decision concerning the absolute height at which such an approach is acceptable can be described as follows: 'as high as evidenced directly or indirectly by the archaeological context'. Corresponding indications are given, for instance, by the height of the topmost step of the side staircase to the roof, the apexes of the vaults in the central interior room (Room 2), and the absolute height of the preserved side of the passage (between Rooms 4 and 5). In the present case, however, the wall height to be reached was contingent upon its required static purpose, whereby there was no objection to a differentiated, stepped height of the complex, ascending from north to south. To counteract the impression that the walls were already stepped in their original state, the vertical wall surfaces were executed irregularly (Fig. 566).

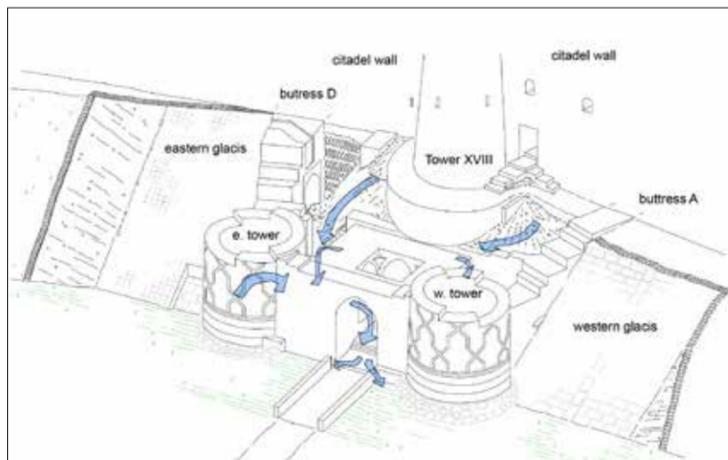
Fig. 567 Isometrical view of the supporting structure, drainage system of surface water

The decision not to vault the central room (Room 2) and not to build a roof over the lateral rooms and the towers made the installation of gutters and channels necessary for draining off rainwater from the complex's fully watertight surfaces and floors (Fig. 567). Drainage of the interior surfaces of the towers is achieved via the stairs down into the towers' anterooms. A possible outflow along the walls of the towers was not chosen as alternative, because it would
