The Timurid Gateway – Excavations in Trench 3

Archaeological Context

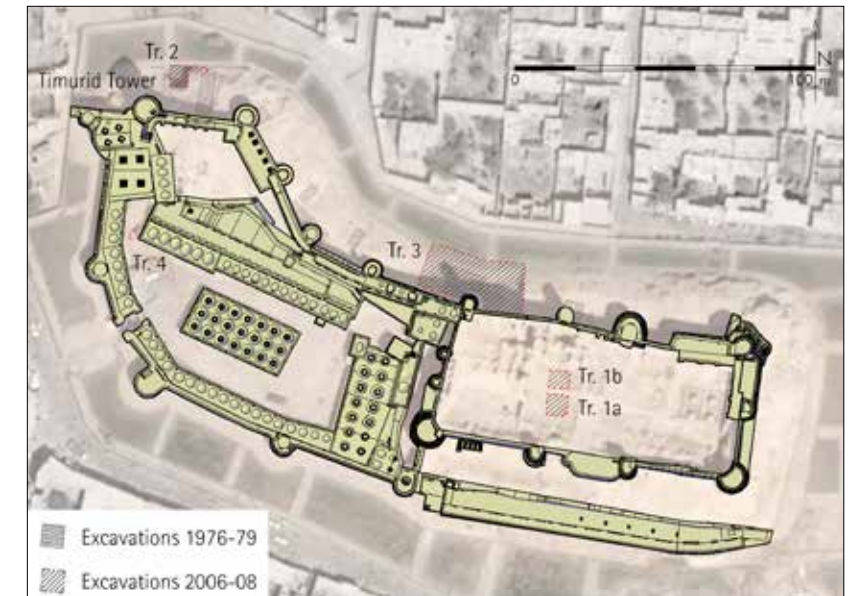
Fig. 306 Schematic plan of the citadel wall, location of excavation trenches

The so-called Tower XVIII is located at the transitional area between the 'upper' citadel in the east and the structures in the west that are mainly built at a much lower position. At this point the outer wall of the citadel, which runs straight from east to west, bends slightly to the northwest (Figs. 306; 311) and, after further changes in direction, leads to the Timurid Tower at its western end (Fig. 306).

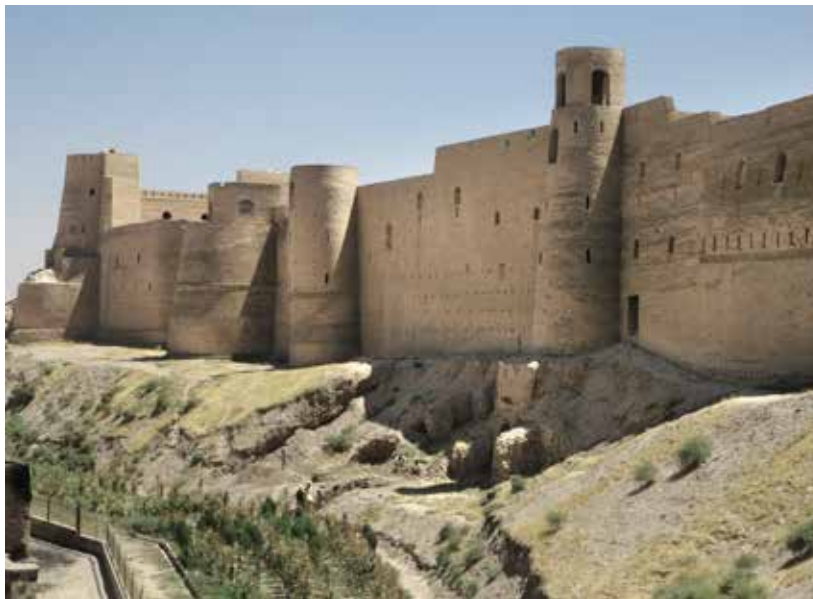
Fig. 307 Surroundings of Trench 3 before beginning of the excavation in 2007

As the citadel slope is comparatively steep in this area and in the recent past already large amounts of debris have been removed (Figs. 307; 309), the place offered a good possibility to examine deeper layers of the citadel mound and thus to gain information especially about older periods of the city of Herat. Furthermore, this part of the structure provided the opportunity to investigate a series of ruins protruding from the surface of the slope debris (Fig. 310), which were neither documented nor addressed with even vague interpretations.

At the beginning of the present investigations a number of building structures were well recognisable on the northern slope of the citadel hill near Tower XVIII (Figs. 307; 310): Directly below the tower there is an approx. 2.60 m wide gate with a pointed arch, the opening of which is blocked from the inside with carefully placed, alternating layers of fired bricks set at a slant and large flat stones (Figs. 310; 339; 340). As far as could be discerned only square bricks were employed for this purpose. Two rectangular brick blocks (c. 3.30 x 1.90 m) flanking the gate complex could be identified which were structurally connected northwards with the gate (no joint). They showed remains of architectural elements that can equally be assigned to the gate itself, such as i.e. the base of a vault made from vertically aligned bricks (Figs. 432; 447).

By contrast, in 2007 practically nothing could be seen of the features from the Unesco excavation in 'Trench H' (Fig. 308) any more. Only the lateral boundaries of the excavated area, the 4 m high, *in situ* section in the east of the area as well as a significantly flatter section in the west were still discernible (Figs. 307, 311; 382; 383); thereby, these profiles were not changed or enlarged in the following years.

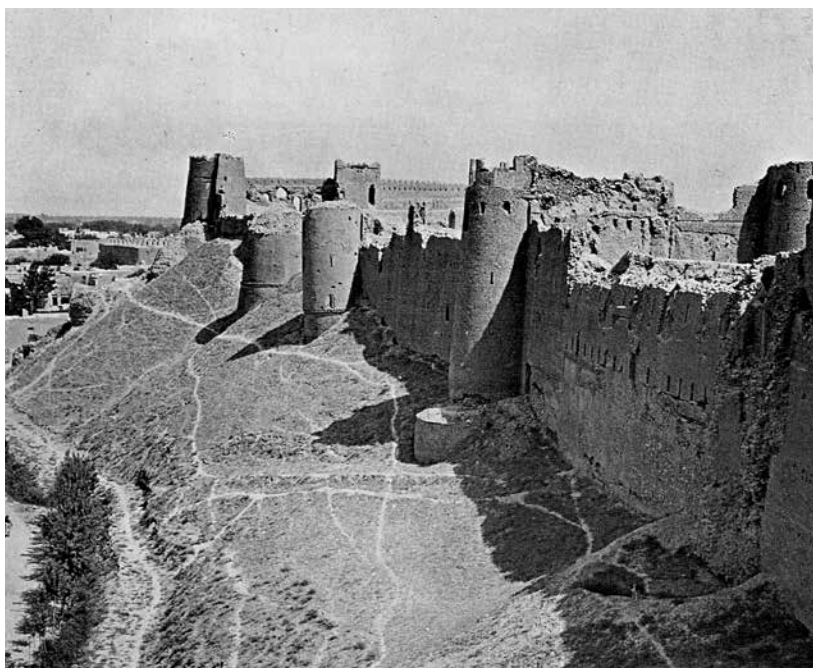
Fig. 309 Northern slope of the Citadel mound prior the Unesco restorations of 1976-1979 (Bruno 1976, 16)

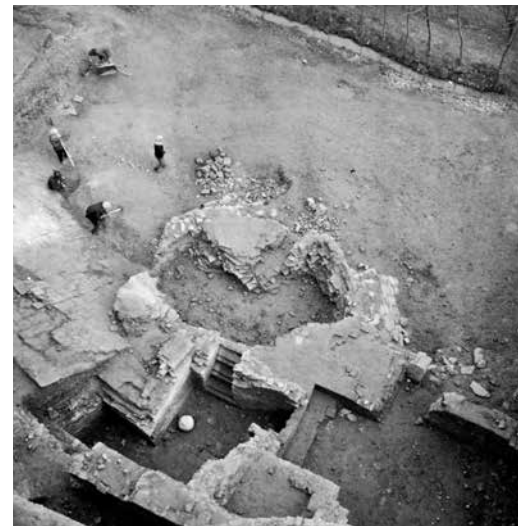
Fig. 308 Unesco excavation 1978, Trench H (van Eenhooge 1981, 90 Fig. 58)

Although a part of this architecture was excavated from April to September 1978 by a Unesco team (Trench H), there is only brief mention of these excavations with merely one photograph (Fig. 308).¹ In 1978, apart from a round tower made of fired bricks and large stones, a small 'guard room' was unearthed here (Fig. 308), on the floor of which – according to the photograph – a big stone sphere lay upon the ground, and to its south another room, a 'square domed' room.² The structure was

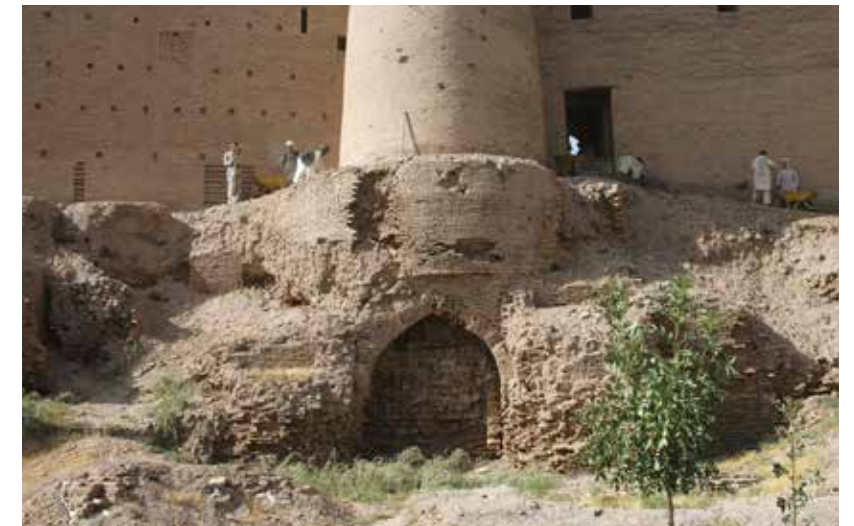
Fig. 310 Trench 3 before beginning of the excavation 2008, visible structures on the surface of the slope, i. e. a blocked pointed-arch gate and base drum of Tower XVIII; from north

East of the pointed-arch gate, various brick walls could be localised on the slope (Fig. 310), which presumably had not been unearthed prior by the Unesco excavations, for they are not mentioned in the preliminary reports.⁷ Here also smaller restorative measures must have been carried out by the Unesco, which, however, are not immediately apparent as such: one part of the brick wall directly below the broad tower cylinder at the foot of Tower XVIII must have already been reconstructed at that time, because it stands upon a layer of debris, in which remains of plastic foil can be discerned – for the presence of which only Unesco activities in the late 1970s are likely to be responsible.

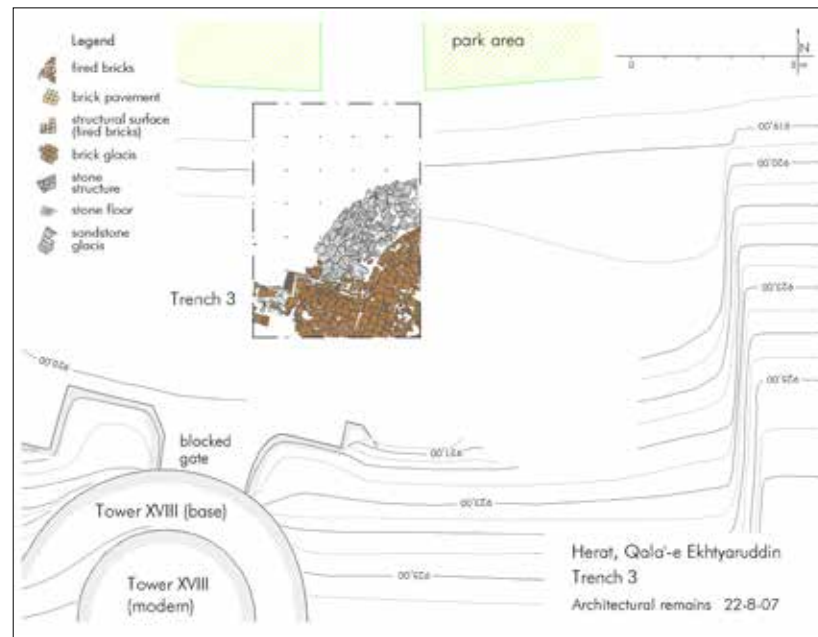
Fig. 312a Trench 3 (2007), excavation area at the start of the 2007 campaign

Trench 3 was begun on August 8th, 2007, as a 2 x 7 m extensive trial trench (Fig. 312a), directly northeast of the structures that were partially unearthed by the Unesco, but not documented at the 'planum' level (Figs. 308; 311).

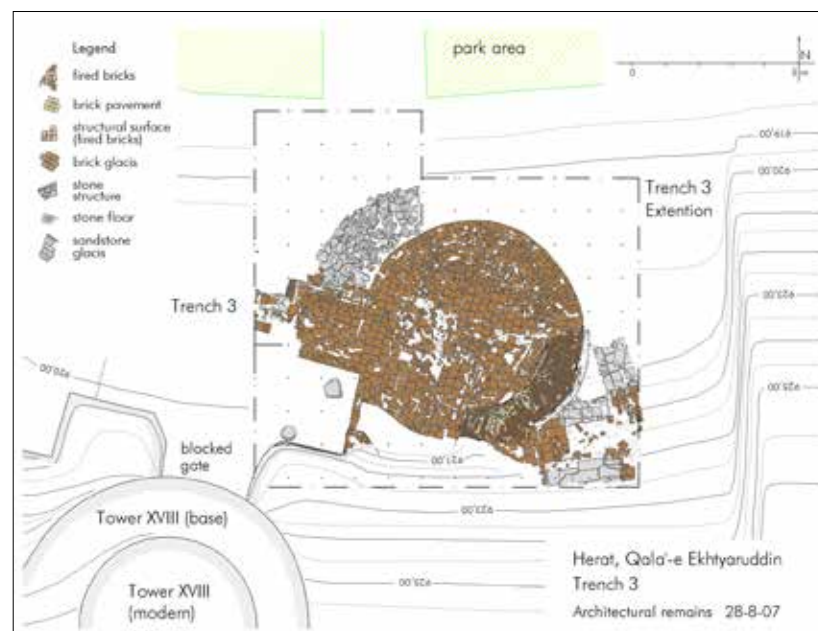
Fig. 312b Trench 3 (2007), excavation area at the end of the 2007 campaign

Due to the expanse of the architectural context, the excavation area was extended to the size of 11 x 11 m, so that the eastern tower could be unearthed in its total dimensions (Figs. 312b-314).

The 2007-section of Trench 3 (Figs. 312a+b) was dug in altogether 10 levels including a deep trial sondage, reaching down to the absolute level of 914.35 m (Figs. 313; 314), that is, c. 3 m below the terrain surrounding the citadel. The finds that came to light were retrieved according to their stratigraphical position and documented. After three weeks the excavation work was finished on September 4th, 2007 and the unearthed architectural remains were three-dimensionally measured, photographed and drawn stone by stone.

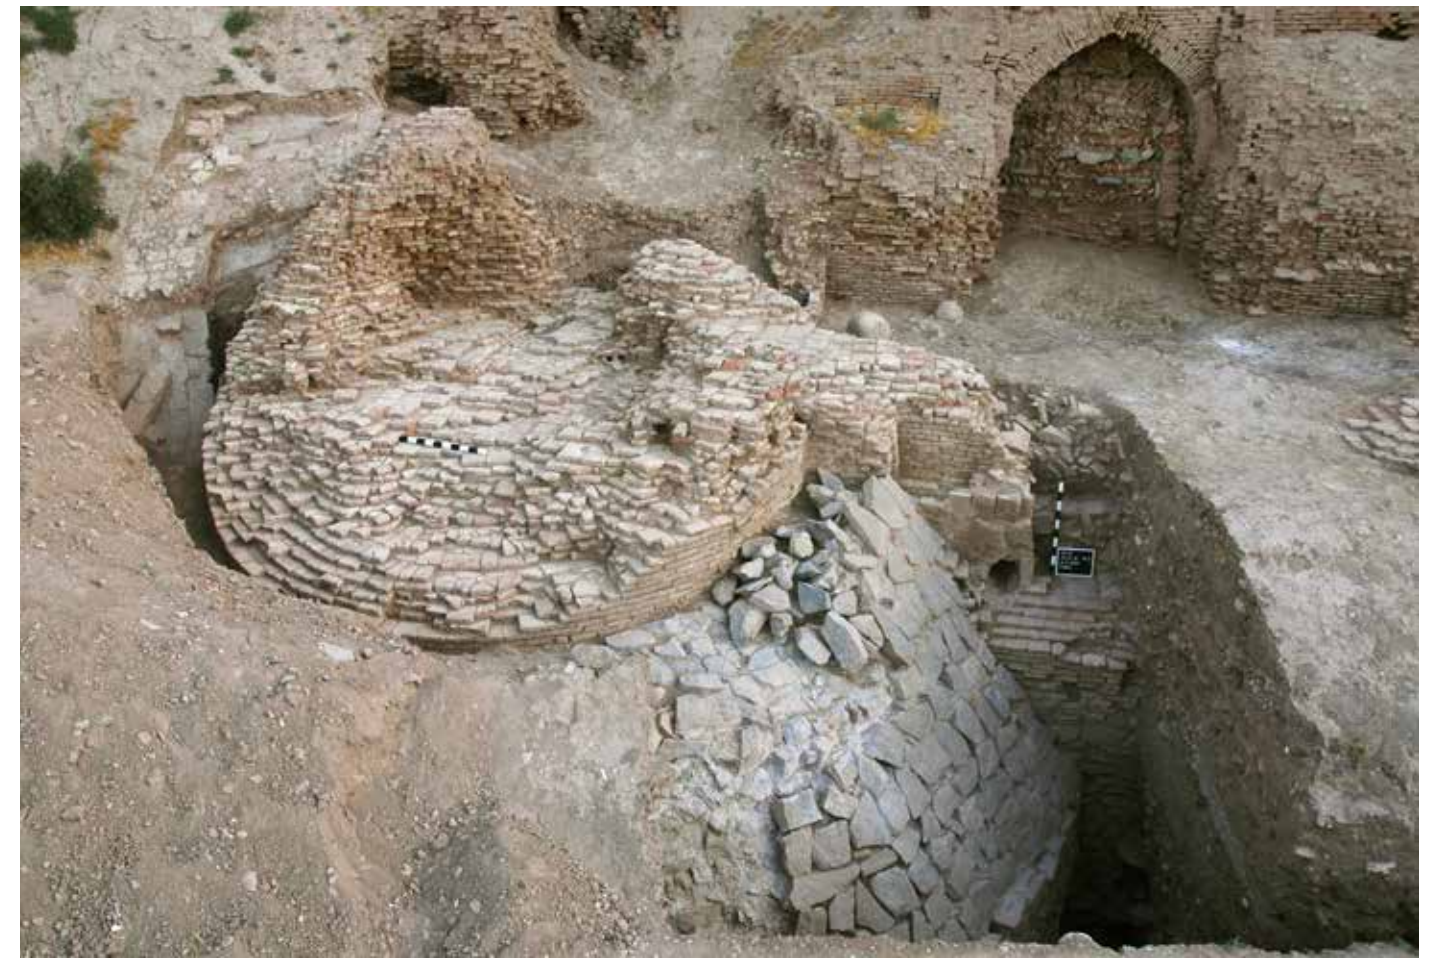
Fig. 313 Trench 3 (2007), eastern tower with stone facing of the foundation; from north

Extensive architectural contexts (Figs. 312-314) were soon found only 20 cm to 30 cm below the rubble layers, which, together with on the surface visible and then cleaned architectural remains, could be identified as another large tower. In the following this tower will be referred to as 'eastern tower', and to the already known 'Unesco tower' as the 'western tower'.

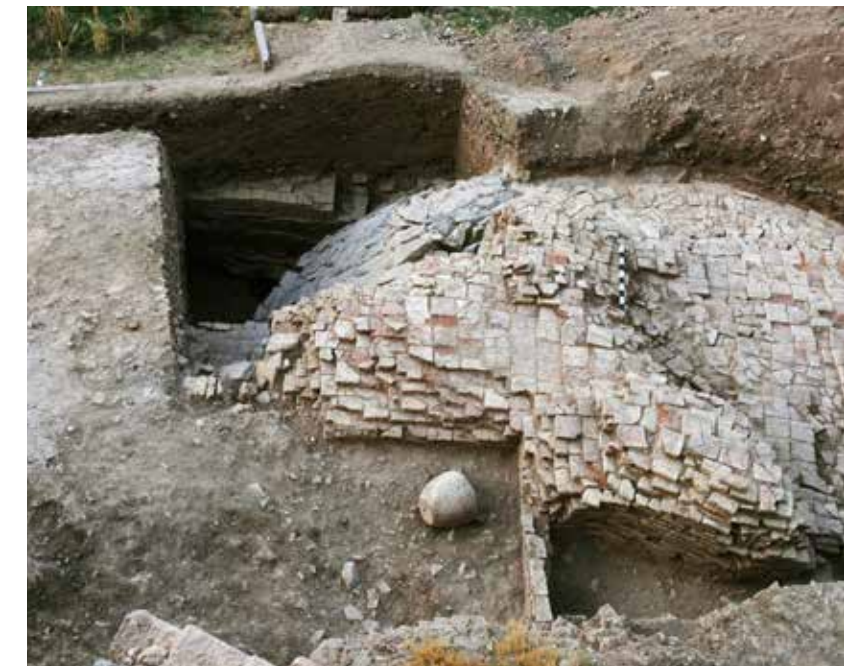
Fig. 314 Trench 3 (2007), eastern tower, in the deep-sounding: remains of a bridge abutment (on the bottom of the trench), in the foreground: Room 1 with sheroid limestone object; from north

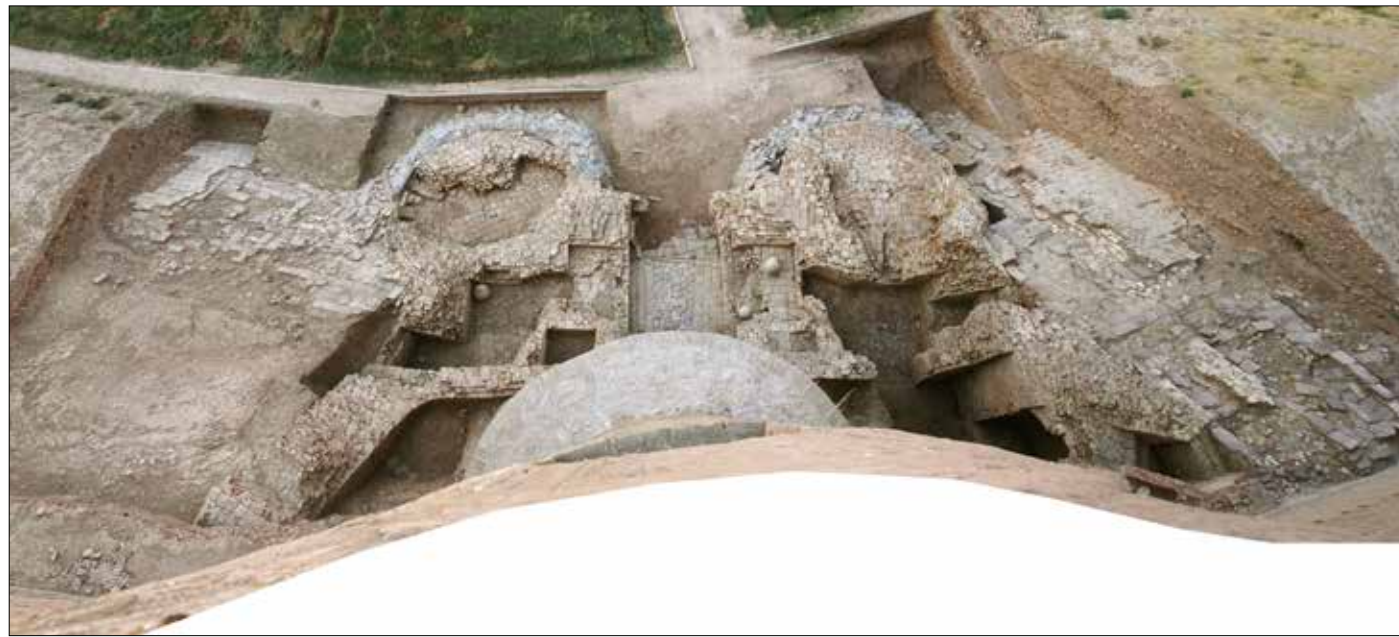
Fig. 315 Trench 3 (2008), excavated architecture, general view from above; from south (assembled photo)

The gate complex displays a conical ground plan (Figs. 315; 316; 318; 319), with the northern outer wall as the base and the two lateral outer walls in the east and west as the flanks. Both northern corners are executed as two large towers. In the south, the complex abuts the citadel wall and Tower XVIII; a separate southern wall was not found in the archaeological context, but must have originally existed.¹⁴ With a thickness of up to 3 m, the lateral outer walls (Figs. 316; 318; 408–416) constitute the mightiest walls of the gate complex; presumably they were also the highest, with a preserved height of more than 7 m (Figs. 320; 409). They do not run parallel to each other, but deviate at an angle of c. 20° from the central axis, thus giving the ground plan of the gate complex a trapezoidal base.

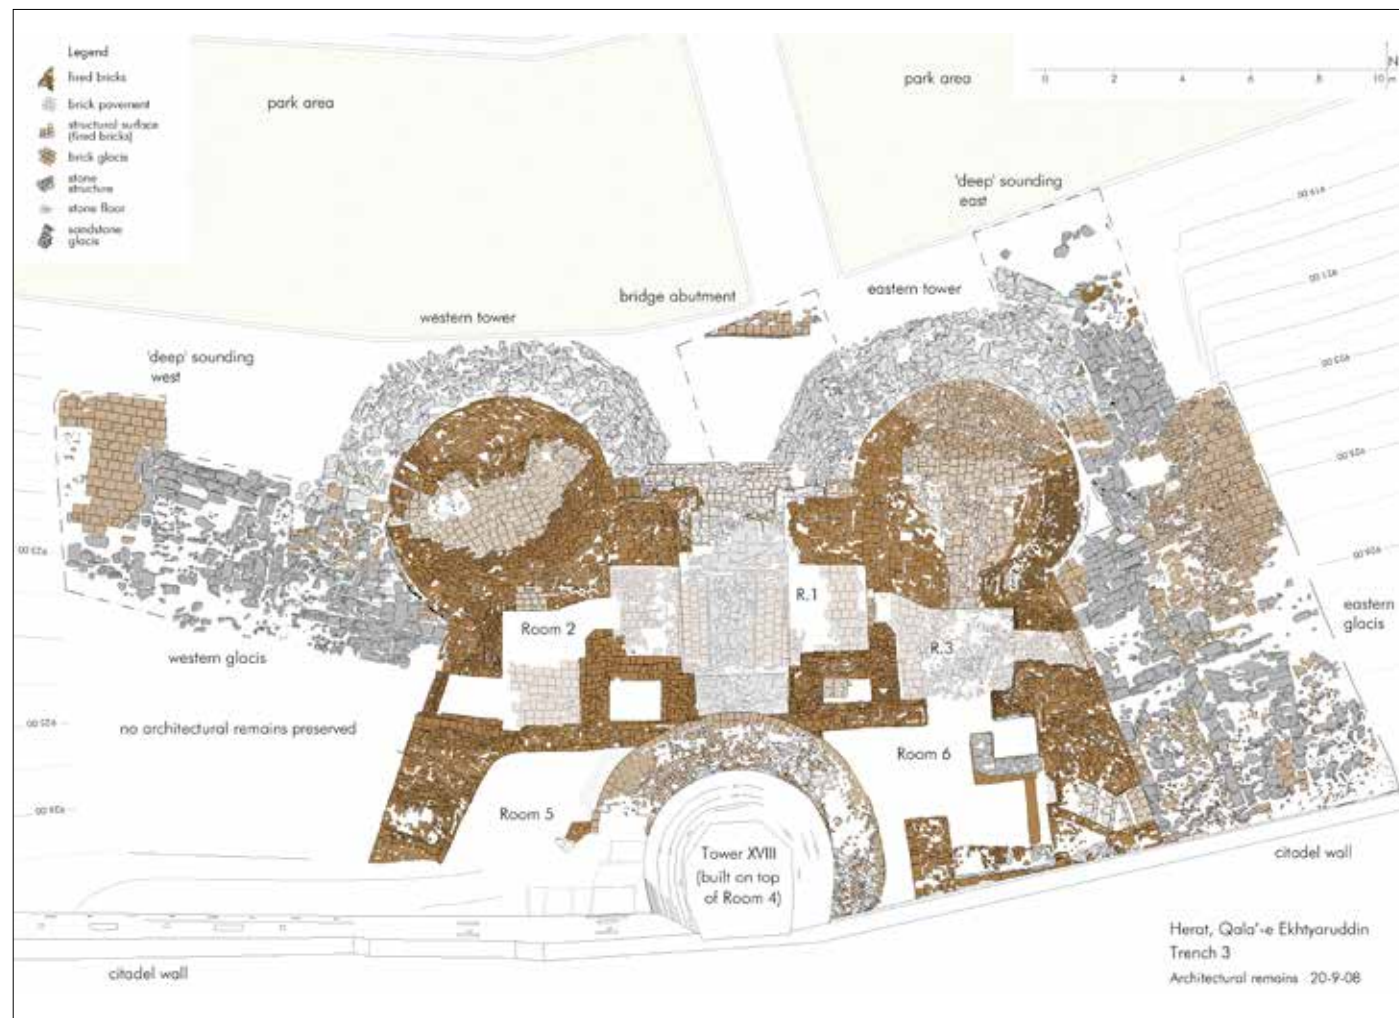
Fig. 316 Trench 3 (2008), excavated architecture, drawing of the general ground plan
