## Investigation of the Citadel Glacis – Trench 2

## Architectural Context and Stratigraphy

### The Glacis

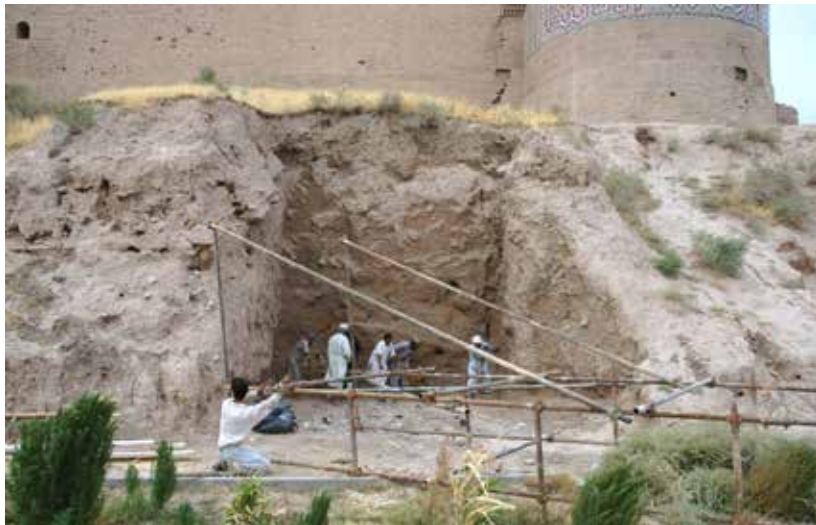
Fig. 277 Trench 2, cleaning of the surface and construction of scaffolding; from north

The digging of Trench 2 began on August 9<sup>th</sup>, 2007 as the first of the two excavations outside the citadel enclosure, where the northern citadel slope is still accessible on its entire length (Fig. 275).<sup>1</sup> There were many opportunities for sondages of several metres depth from the current base of today's citadel walls down to the present street level.<sup>2</sup> Although in the east and southeast of the citadel the base levels of the walls as well as the hilltop levels are slightly higher, no excavation work is possible there without endangering the stability of the architecture *in situ*.<sup>3</sup> In the northwest, in contrast, the conditions were more favourable, as the slope already showed an additional, deep incision: the not backfilled Trench 'B' of the Unesco excavation from 1976 to 1979, in 2007 still reaching more than seven metres into the slope (Figs. 276; 277; 282).

direct vicinity of the trench the slope rises steeply. Even under washed-out, eroded conditions the stone glacis could be identified halfway up, as well as extensive find material on the surface and along the unearthed edges – at least from the filling layers overlying the glacis (Figs. 277; 283).

At the beginning of the work the surface was cleared from debris, leveled, and a scaffolding of 8 m height constructed (Figs. 277; 278). From the upper edge of the section, excavated 30 years before, loose stones and clumps of clay had to be removed, which could have fallen down and would have constituted a risk to the work in that area of comparatively unstable debris layers.

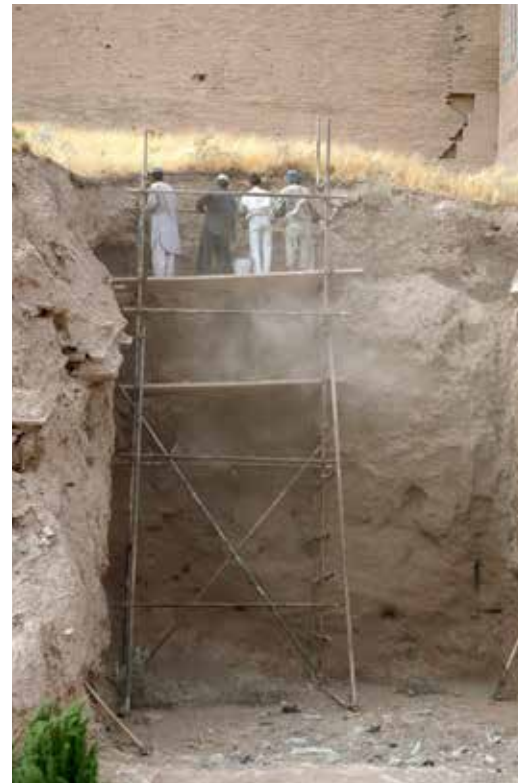
Fig. 278 Trench 2, excavation of the upper layers of the southern section; from north

Subsequently the excavation of the 1979 trench was revived, cutting back its sections in portions of c. 1–1.50 m height and cut 0.30–0.50 m further inwards, then cleaned and straightened (Figs. 278; 288; 290); the unearthed finds were retrieved directly or gathered from the ground after finishing each stage of work. Although the surface was leveled and carefully cleaned after each removal of earth, a few objects in the material originated from outside the current excavation limits. This cannot be avoided when working in this way; however, statistically they can be disregarded. The alternative of cutting a new trench into the citadel mound and reaching down to a total depth of 8 m was not an option in view of the available time frame of only five weeks.

When excavating in the Herat area a considerable challenge is the combination of debris layers with high contents of loess and clay and the typical 120-day wind in the summer months, which is strongest in July with an average of 5.10–7.70 m/s.<sup>5</sup> In the whirled-up dust finds and structures could only be recognised with protective goggles (Figs. 278; 279).

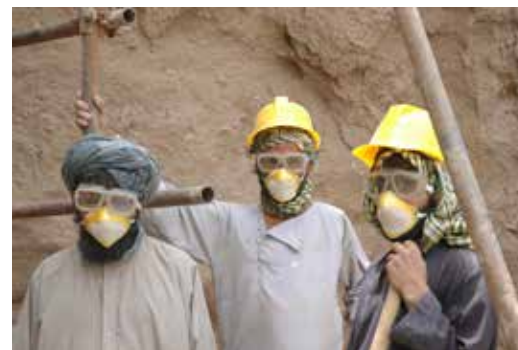
Fig. 279 Trench 2, working in Herat's summer wind conditions

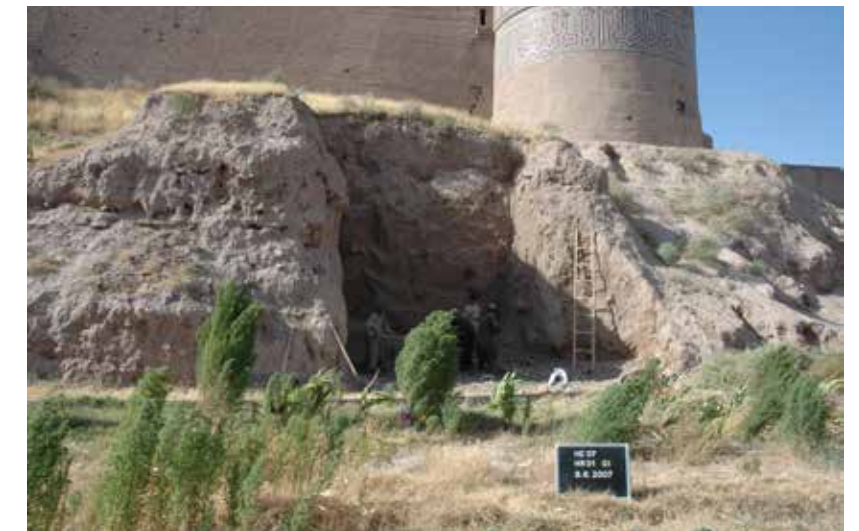
Fig. 282 Trench 2, start of the excavation in 2007; from north
