The Timurid Gateway – Reconstruction and Conservation

Preceding Measures

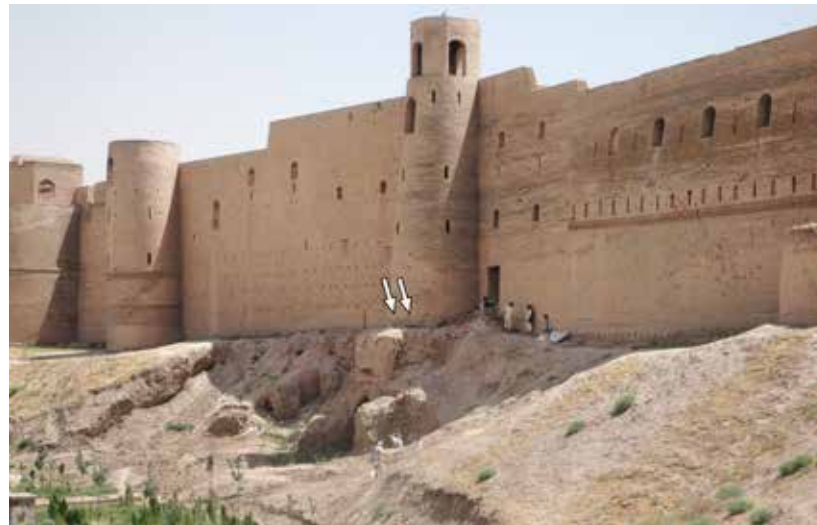
Fig. 560 The gateway area prior to the 2008 excavations, localisation of the cracks in Tower XVIII; from west

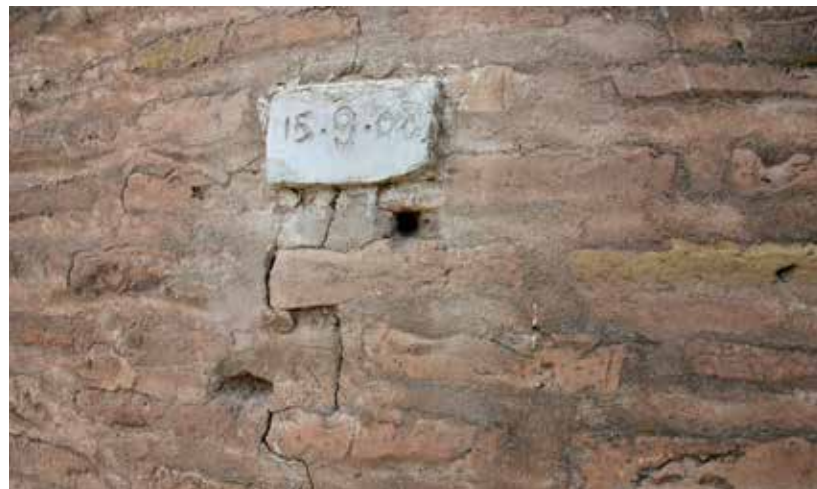
Fig. 561 Tower XVIII, above the gateway, setting cracks and plaster seal of 2008

⁷¹ The cracks were documented and for further observation of this development controlled by means of plaster seals.

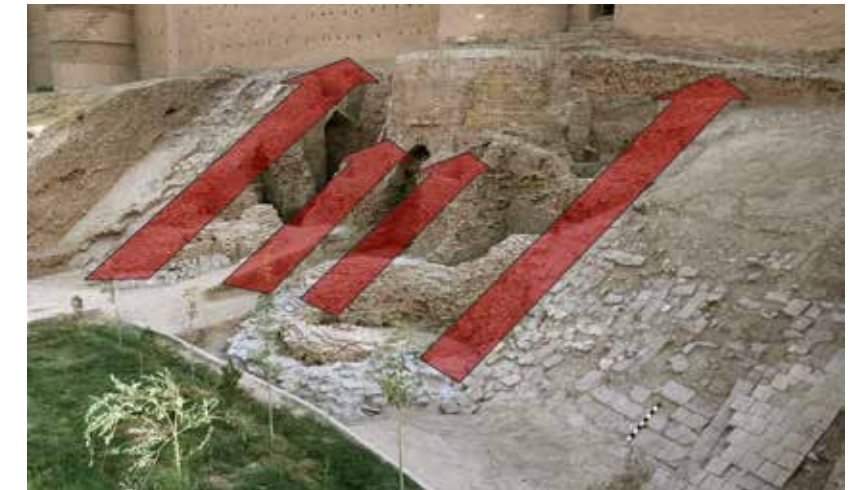
Fig. 562 Gateway at the end of the excavation 2008, schematic display of the necessary supportive system (cp. Fig. 563)

Composition and structure of construction principally follow the prerequisites of statics. The expert assessment called for four massive buttresses, leading from the present ambient level up towards the citadel wall (Figs. 562; 563). In their architectural implementation these four buttresses correspond to the two outer walls as well as the two north-south oriented inner walls of the gate complex (Fig. 563). By means of a three-dimensional visualisation (Fig. 564) and

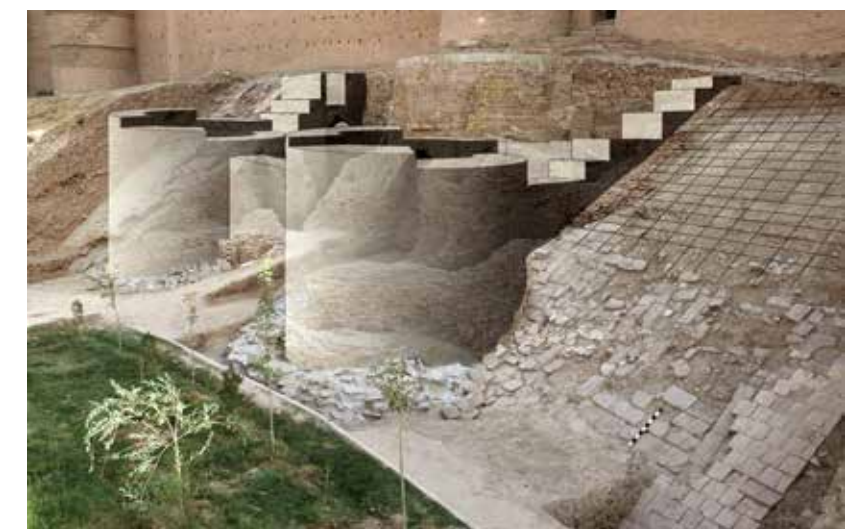
Fig. 564 Final planning of the supporting structure, schematical visualisation

isometric drawings (Figs. 563; 567) the construction was planned and the individual components were drawn in proportion. In coordination with the building expert the statically necessary heights of walls and towers were calculated, and the appearance of the upper termination of the complex was defined in accordance with the proposed aim of mostly displaying a ruin. This appearance was also tested in 2008 by means of a three-dimensional visualisation and served as reference for the actual construction work during the following one and a half years (Fig. 564).

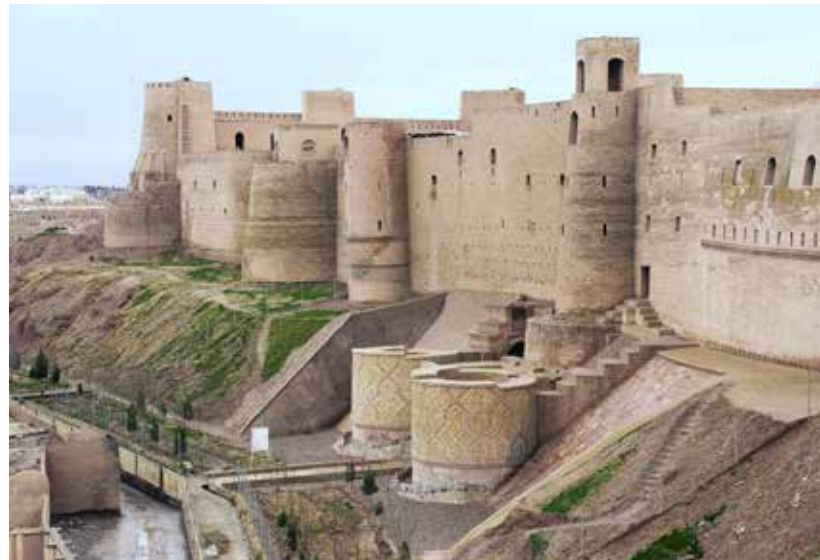
Fig. 565 Completed supporting structure, October 2009; from west

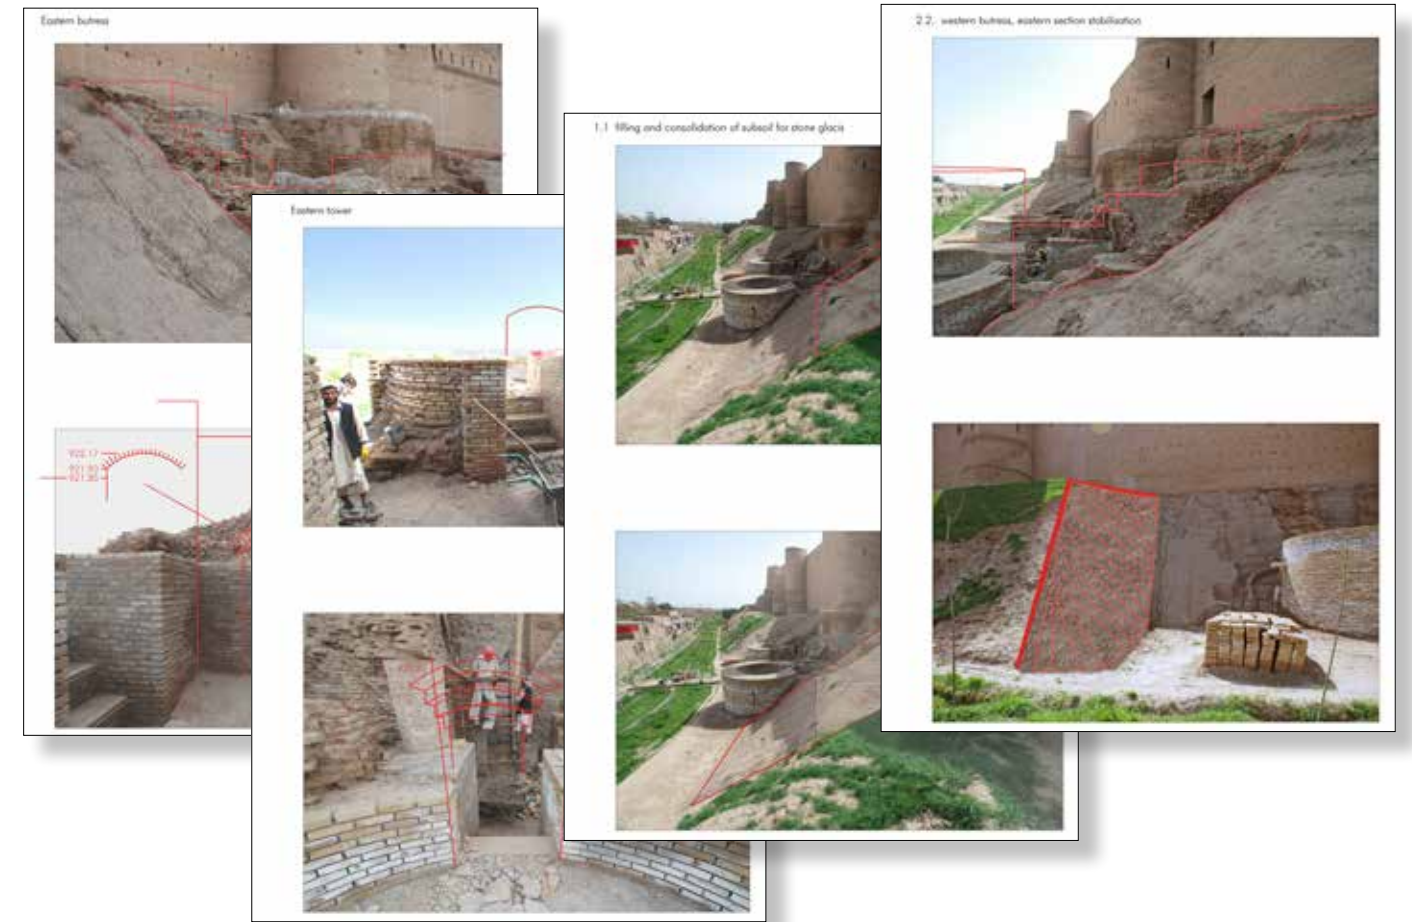
Fig. 568 Graphic instructions for local architects and supervisors

The necessary manuals, plans and specification sheets were prepared by the author (Figs. 568–570), and the progress made in daily work was documented photographically by the local supervisors and/or the author. In a first step the most urgent work was to be carried out, especially the consolidation of the excavated architecture, a stable backfilling of the excavated rooms south of the gate complex, and the construction of the masonry shell around the two towers. This work was finished by the end of the year and before January, when the frost period set in.
