Guzara

Catalogue

Ziyaratgah, Qal'e (Ziyāratgāh, Qal'e)

Cat. No. Gz 1
Position Lat. 34° 11' 28.98" (N) Long. 62° 08' 55.13" (E) Height 872 (m)
Location 17.5 km south of Herat, 1 km southeast of the town of Ziyaratgah, 6.7 km west of the road from Herat to Kandahar; at the brink of the desert. Maps pp. 501; 502
Size circular, diameter c. 100 m, area of 7,800 m²
Type settlement, fortified (?)
Date 13th/14th CE (?) (pottery)
Condition walls almost completely decayed, only traceable as clay embankments

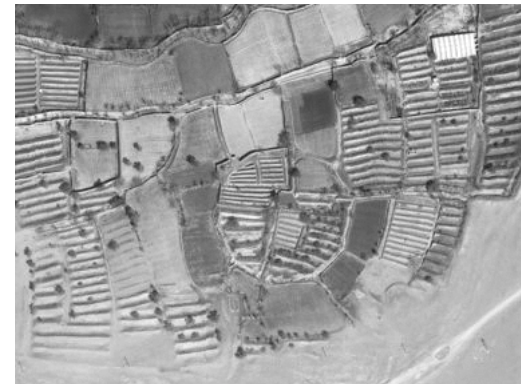
Fig. 1082 Aerial view of the site

A decagonal site with a diameter of c. 100 m, surrounded by a wall, possibly with bastions and a moat, is clearly identifiable in the aerial photograph (Figs. 1082; 1084). In the southwest remains of a mud-brick tower were visible on the ground, and a gate was possibly located at the southern edge. The interior is used for grape cultivation, traditionally grown along earthen walls.

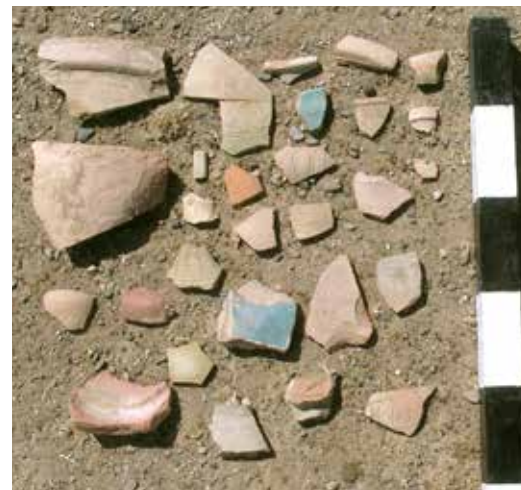
Fig. 1088 Surface collection, pottery

Finds: the sherds (Fig. 1088) include a few thick-bodied turquoise-glazed earthenware bowl sherds (nos. 1; 2) and unglazed fine red or buff plain and heavy body sherds of larger jars and bowls, often slipped, some with folded triangular rims (nos. 7–9). Apart from a few larger, wavy incised body sherds (nos. 10; 11), some relief-moulded fragments are present, some thick-walled, others fine with a cross-hatched band and turquoise-glazed dots or a fluted panel pattern (nos. 3; 4; 6). The assemblage lacks the typical green-glazed bowls, but indicates a 13th/14th-century date.

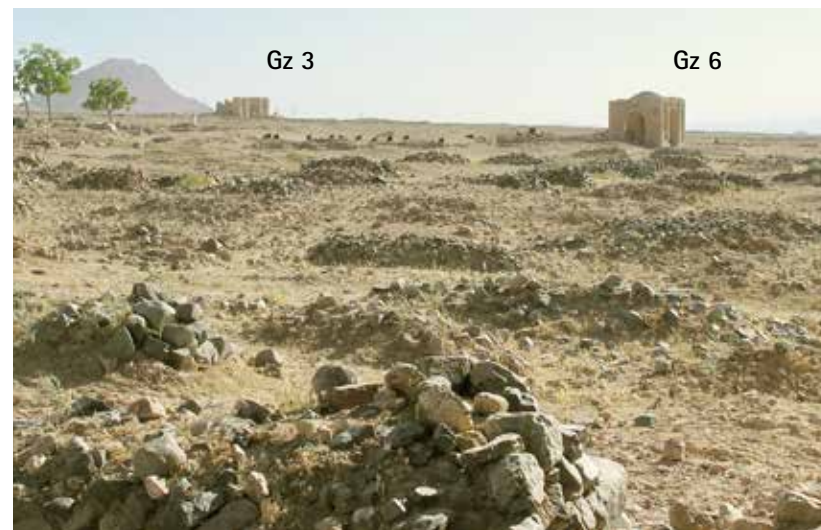
Fig. 1090 General view of the northern surroundings, from northeast

The building stands on the gravel plain between the oasis and the mountain feet, 1 km south of the Jame Masjed Ziyaratgah (Gz 10, Fig. 1131). A wide stretch of the plain is covered by cemeteries, underlining the importance of this area, with the Khaneqah Molla Kalan in its centre and two *ziyarat*s nearer to the oasis (Gz 4 and Gz 6; Figs. 1084; 1090; 1131).

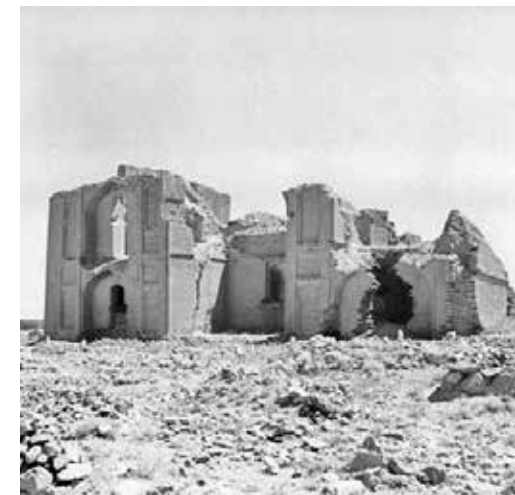
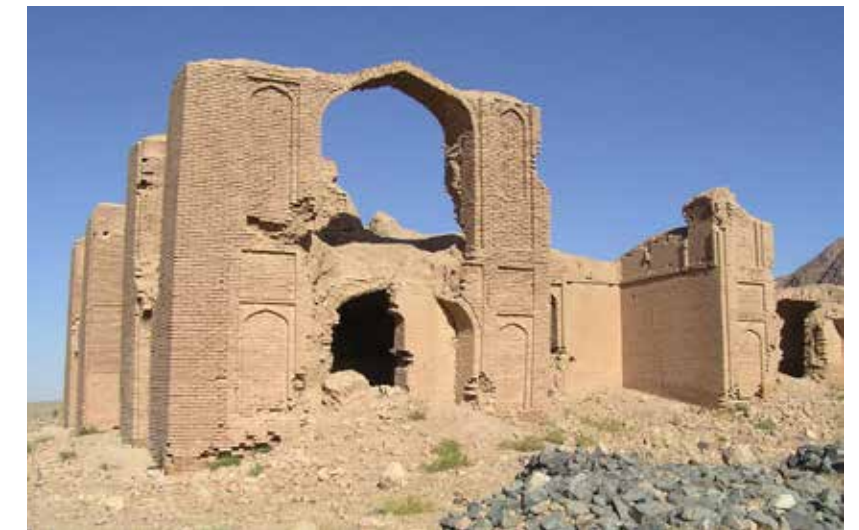
Western façade (Figs. 1095–1097)

The western *iwan* is of a lower overall height than the one to the north, marked by a lower base point of the central arch, about halfway up to the upper floor. It is flanked by two superimposed niches on either side. In contrast to the northern façade the niches are all of equal width and have pointed instead of ogival arches (Fig. 1096). With a depth of c. 70 cm they are also significantly shallower than the more than 2 m deep niches in the northern façade; narrow passages lead on to the corner rooms on both floors. The design of the western façade is completed by groups of vertically aligned blind niches with pointed, rectangular and overlong pointed arches (from bottom to top).

In a photo taken by O'Kane, some parts of the southern façade are still visible (Fig. 1095). The plain wall in the east was interpreted by Pugachenkova (s. a.) as an indication of a smooth southern façade without *iwan*, but given the poor preservation, O'Kane (1987, 319) and Golombek (1988, 353) left this question open. Yet, the frame of an opening preserved in the southwestern niche of the central room indicates that a passage was present (Fig. 1101).

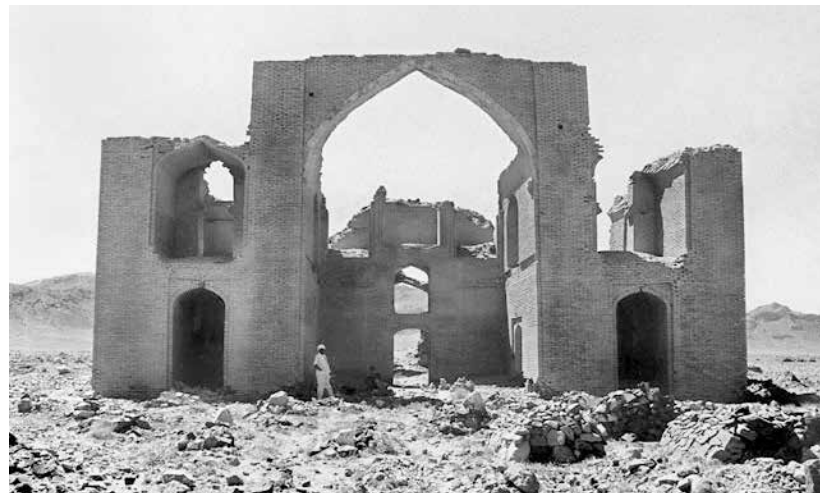
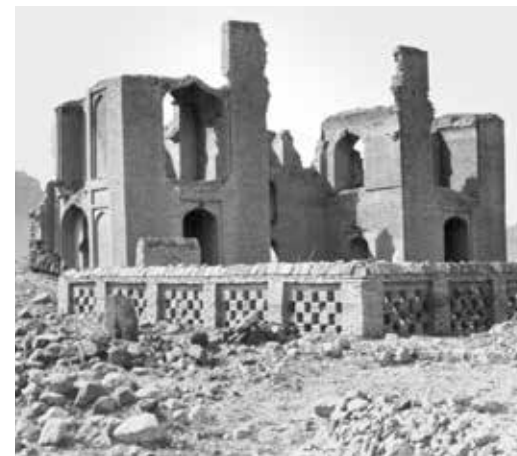
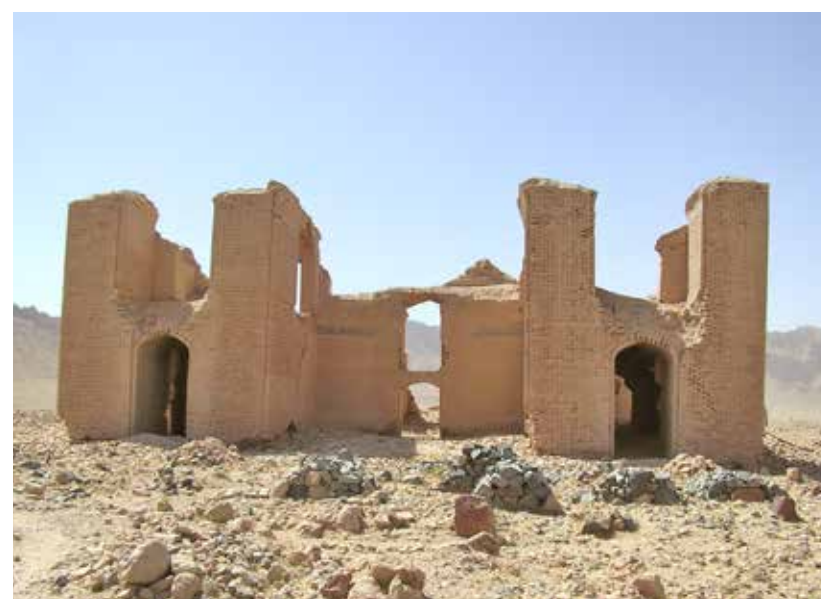
Northern façade (Figs. 1092–1094)

The main entrance *iwan*, facing towards Ziyaratgah, with its raised pointed-arch portal, is still visible in photos taken in 1960 by L. Golombek. The portal arch collapsed in May 1975, struck by lightning or an earthquake (Samizay 1981) shortly before B. O'Kane's (1987, 320) visit in June. It is flanked by passages with segmental arches on the lower floor and by twice as wide ogee-arched niches on the upper floor, all leading to side rooms. The portal, passages and niches are bordered by rectangular frames but, in

contrast to the east and west façades, there are no blind niches in the façades in between. The western wall of the *iwan* has a semi-octagonal *mihrab* on the ground level, already planned at the beginning of the construction, and pointed-arch openings in the upper part of both lateral walls.

Below, at a level just beneath the upper floor, a recessed horizontal field reveals the position of a circumferential calligraphic frieze, of which only the southern parts are preserved (see below), apparently mostly unchanged since the 1960s, as traces of plaster partly covering the inscription are visible in O'Kane's images, too (O'Kane 1987, Fig. 49.3).

A passage with a rather low segmental arch leads to the central room, which received additional light from a pointed-arch niche above (Figs. 1092; 1093), only partly preserved in 2004. The old images show that a blind niche was constructed on top of the latter; together with the rear corners of the *iwan* they formed the - now collapsed - transition zone of the *iwan* dome (Fig. 1092), possibly originally lined by *muqarnas*.

Inscription (Figs. 1094; 1105; 1106)

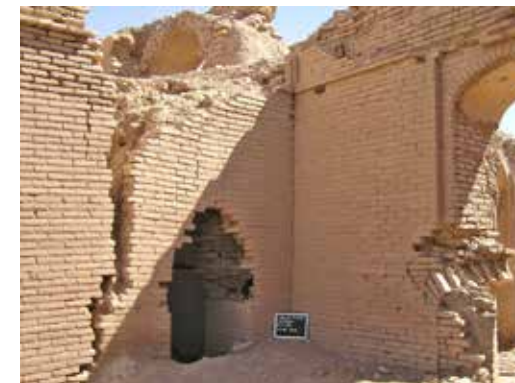
Fig. 1097 Western iwan, detail, from southwest

The northern lateral wall of the western *iwan* has openings to the lower and upper corner rooms (Fig. 1097). Two superimposed openings in the rear wall open up to the central room, as in the northern *iwan*, however, the niche above is absent and the design is less complex. The passage into the domed hall was blocked at a later stage by the addition of a *mihrab* in the central room, already noted by O'Kane (1987, 320) and confirmed by remains of the angular back of the *mihrab* inserted into the passage (Fig. 1101). They show that the *mihrab*'s back wall must have protruded into the western *iwan* hall.

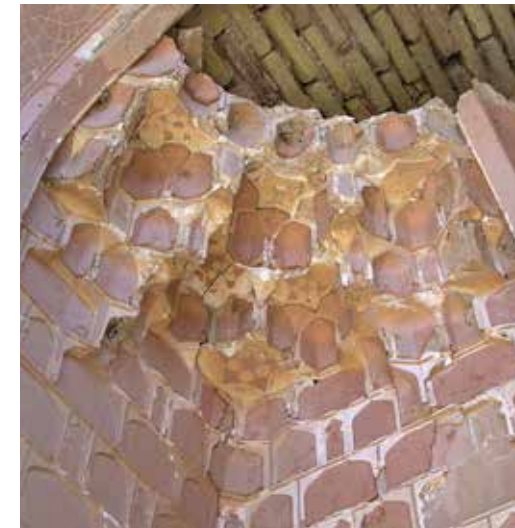
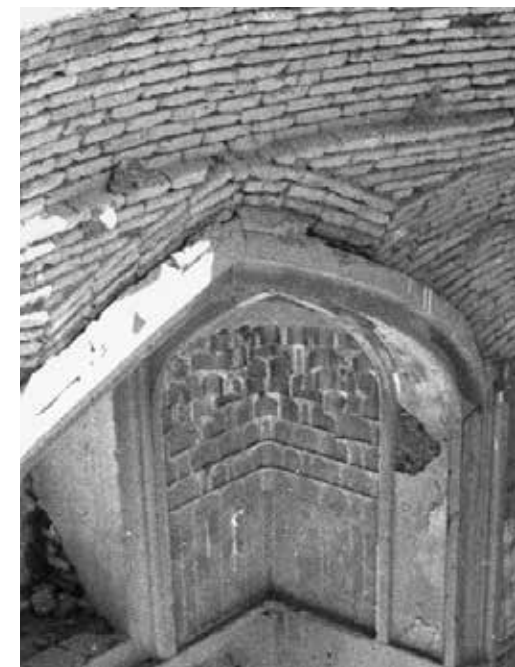
The room was plastered with clay and covered with layers of white and red paint. The decorative scheme consists mostly of 'painted architectural plaster ornaments' (Golombek/Wilber 1988, 353). The beginning of the transition zone is marked by a single-brick layer cornice, running along all extant walls, including the eastern one. Above begins the plasterwork of ribs and squinches with *muqarnas*, followed by pendentives (Figs. 1100–1104). The niches, ending in pointed-barrel vaults, received *muqarnas* applications in the corners and were thereby transformed into more elaborate semi-domes. The corner squinches of the central room were likewise decorated with *muqarnas* (Figs. 1100; 1104).

Three layers above the arch of the niches, constructed with bricks laid on edge to enhance stability, begins a circumferential recess of c. 7 cm; above follows the dome, built in ring layers (Figs. 1102; 1104). Nothing remains of the decoration on the dome, apart from the transition zone and, below, parts of the *muqarnas*.

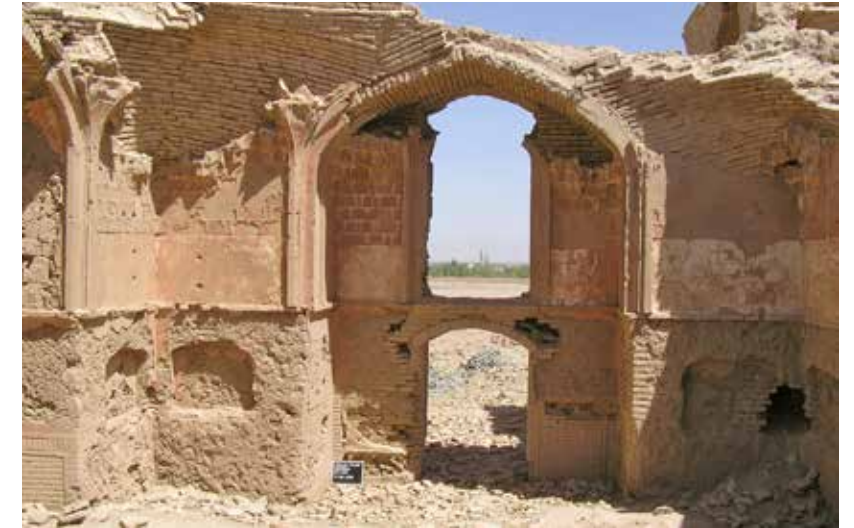
Fig. 1103 Central room, northern niche, from south

Central Room (Figs. 1100–1104)

The central room covers the entire height over two floors. It has a cruciform ground plan with four large niches in the main axes, the northern one being the deepest. It was accessible through a relatively low passage from the large northern entrance *iwan* and probably through the southern and western niches, as argued above, but not through the eastern access. The western passage was later blocked by the *mihrab* (Fig. 1101). The dome has collapsed long before the 1960s. Samizay (1981) assumed that it probably was a double dome, the lower one with stucco decorations and paintings (Samizay), but O'Kane (1987, 320) believes that the dome was most likely a single-shell construction.
