### Room Book

#### Methods of Documentation and Basis of Survey

### Construction Methods, Masonry, Architectural Details

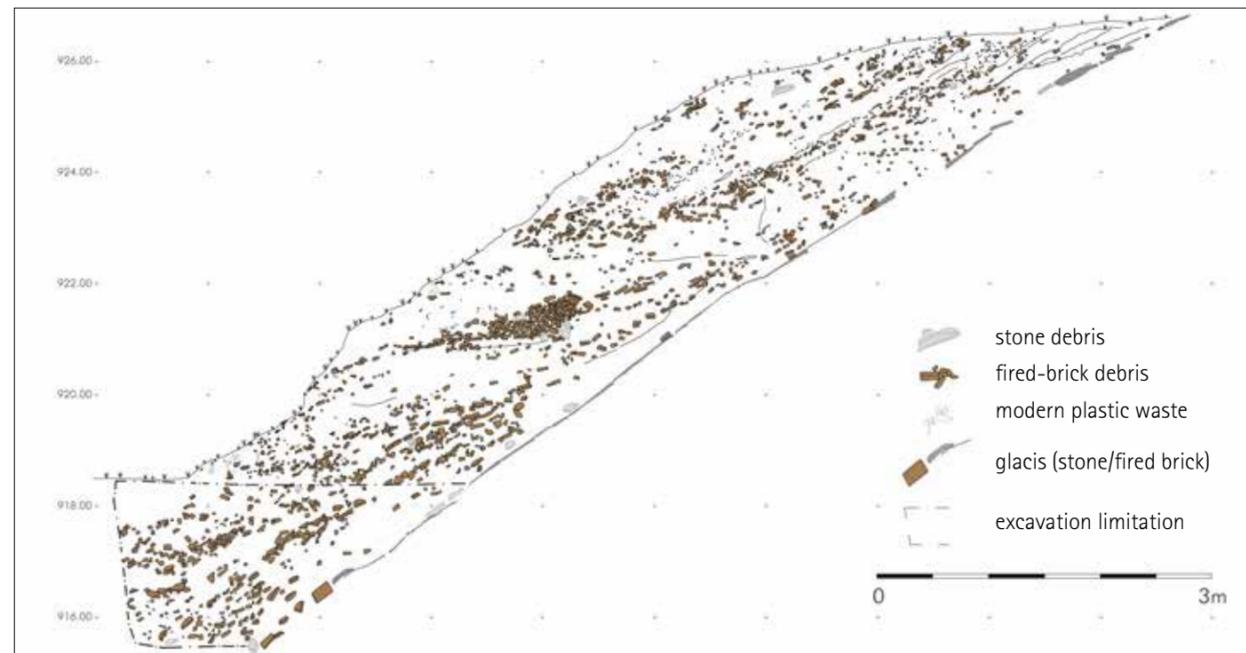
Fig. 382 Trench 3, eastern section, drawing true to scale (note the oblique layers down to the deep sounding)

During both excavation campaigns, the documentation was carried out by means of digital and analogue photography, graphic representation of plana and sections as well as description of stratigraphical units. The high eastern section<sup>1</sup> was drawn (Fig. 382), while the flat western section<sup>2</sup> (Fig. 383), in contrast, was documented in orthophotography, because it contains only the same upper slope and debris layers, which have already been fully included and documented in the eastern profile.

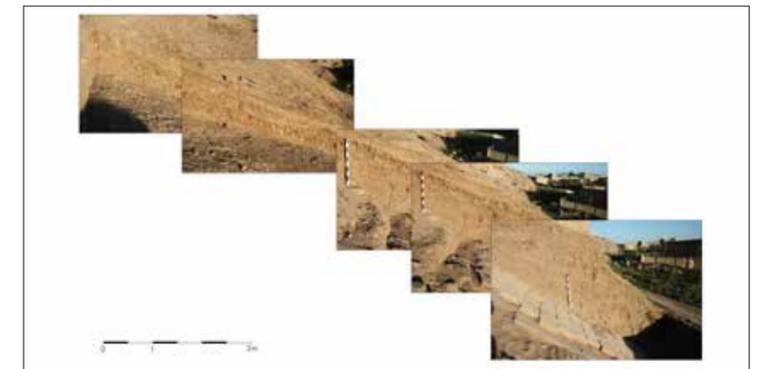
Fig. 383 Trench 3, western section, assembly true to scale, rectified photos

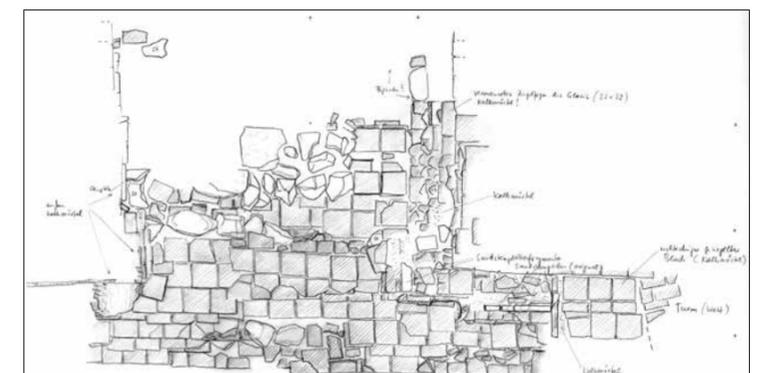
Fig. 384 Excavation documentation: pencil drawing true to scale

The excavated structures were graphically documented as plans and sections (Figs. 384; 389), then levelled (Fig. 385), subsequently digitalised (Figs. 316; 333; 339) and integrated into the three-dimensional recording of the citadel (Fig. 386).

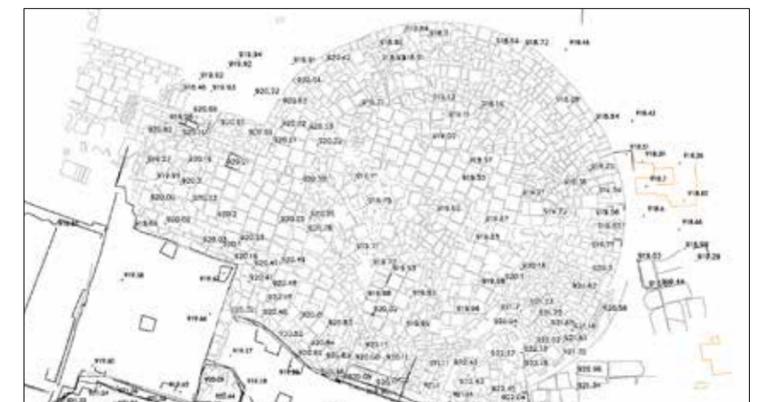
Fig. 385 Documentation: combination of drawing and total station measurement

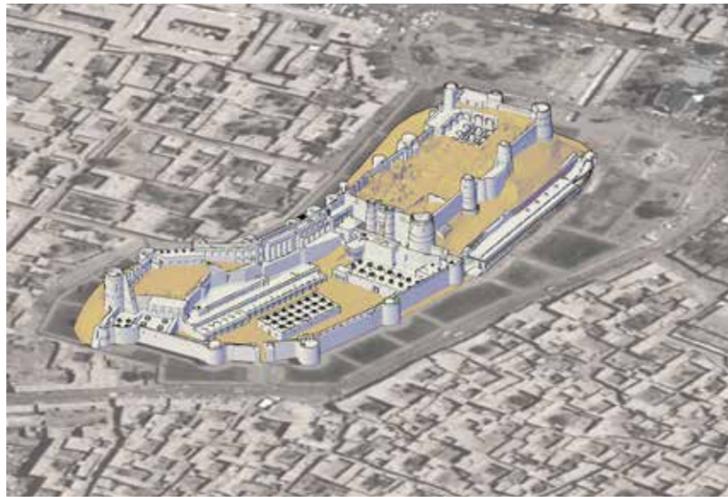
Fig. 386 Herat, old town, aerial photo with 3D model of the citadel; from west

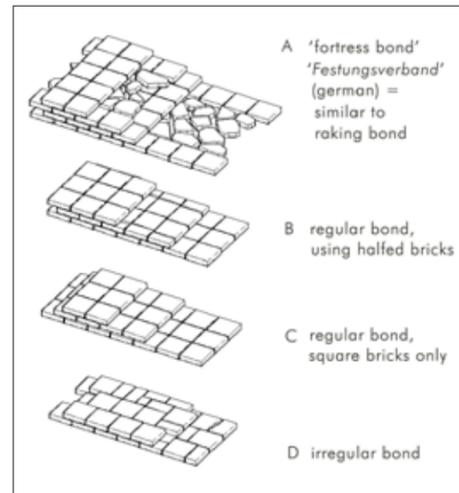
Fig. 387 Gateway, masonry bonds, schematic

The common building material of the Timurid gate complex is constituted by walls of square fired bricks in sizes from 23 x 23 x 5 cm to 25 x 25 x 5 cm, mostly built with simple mud mortar (among others Fig. 396). Stable masonry bonds can hardly be achieved with the use of square bricks alone (Fig. 387c). Such bonds are only stable, if the bricks partly overlap in transverse as well as longitudinal directions of the wall (overlap dimension), so that the joints are not placed directly on top of each other. The smaller formats (half-sized bricks) necessary for this purpose were not prefabricated – as could have been expected, but consist exclusively of square bricks cut in half or reduced in size.

The masonry bond is not consistent (Fig. 387), which could be comprehensively documented and is exemplified, among others, by the eastern outer wall, several metres of which are preserved (Fig. 389 – see also: Fig. 409). In order to avoid superposed joints here as well, bricks of different sizes were aligned. Thereby, the attempt to maintain an even course of a central masonry bond is noticeable: the bricks were laid centrally upon the joints of the course underneath.<sup>3</sup> The wall was mostly built as an irregular bond (Figs. 387d; 389), in appearance similar to a stretcher bond, the courses of which are irregularly placed: the c. 76 cm thick east-west oriented wall, whose pointed-arch gate is blocked, shows an entire course of whole bricks laid in rows of three followed by one course with halved bricks on the edges and two whole bricks inside (Fig. 387d).

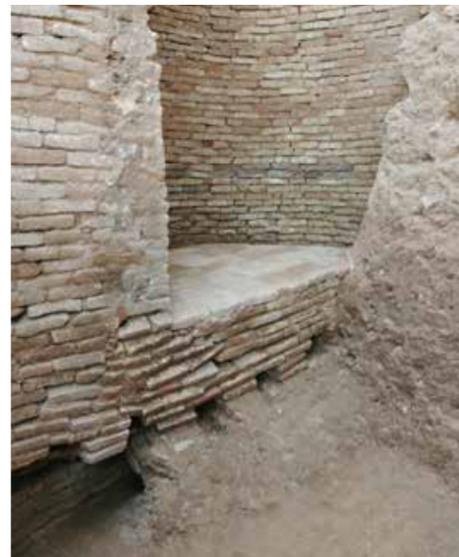
Fig. 388 'Niche Room' (Room 6), recesses in the foundation for the placement of horizontal beams

this constructional feature too (Figs. 460; 461). During the excavation these characteristics were revealed both as recesses in the façades of the walls (Figs. 388; 389; 394), as well as blank spaces within the masonry (Figs. 325–327; 401; 403).

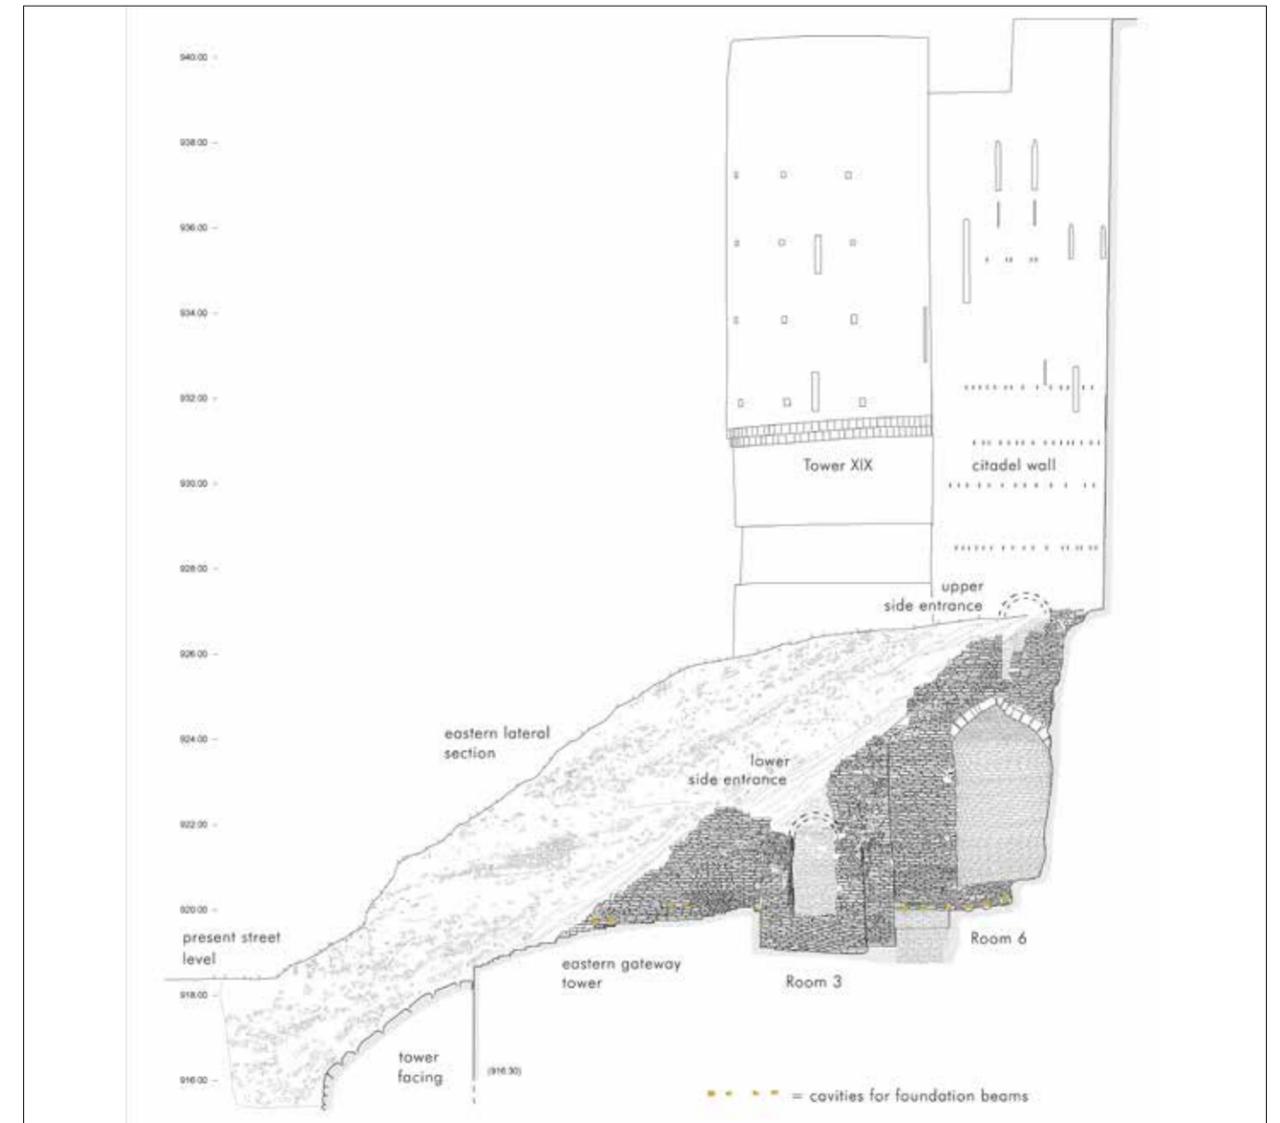
Fig. 389 Gateway, eastern lateral wall, wall design of the inner part (Rooms 3 and 6)

A distinctive constructional detail is the use of longer foundation beams (Figs. 327; 389; 394). These up to 3 m-long timbers were laid in short distances, mostly in the lower courses, thereby increasing the stability of the whole construction. This construction method was applied in the two towers even in several courses, one on top of the other (Fig. 403). It seems to have been suited primarily for very heavy architectural components such as the towers (Figs. 325; 326; 389; 394; 403) and the several metres high eastern outer wall (Figs. 388; 389; 457), but also for smaller constructions (e. g. piers of the bridge over the moat, Figs. 424; 425). Individual walls built later show

The interior of the tower is extensively destroyed, but the floor must have been at the altitude of 920.65 m asl, which is also indicated by the height of the threshold in the south (Figs. 389; 395). This access is c. 1 m wide and corresponds in position and size to the entrance of the western tower. Below the ground level remains of at least eight preserved longitudinal cavities, running through the entire tower construction, were found, four of which range from the centre of the tower diagonally towards the northwest, four others to the northeast (Fig. 394). The inner width of these cavities measures c. 12 cm, and they are one to two brick courses high. In the southern part of the tower remains some fitting timber fragments were found (Fig. 327), the age of which could be determined more precisely with radiocarbon dating.<sup>7</sup> The exact dating information complies with the usual two probability ranges for radiocarbon dating within which each value can apply. It thus provides

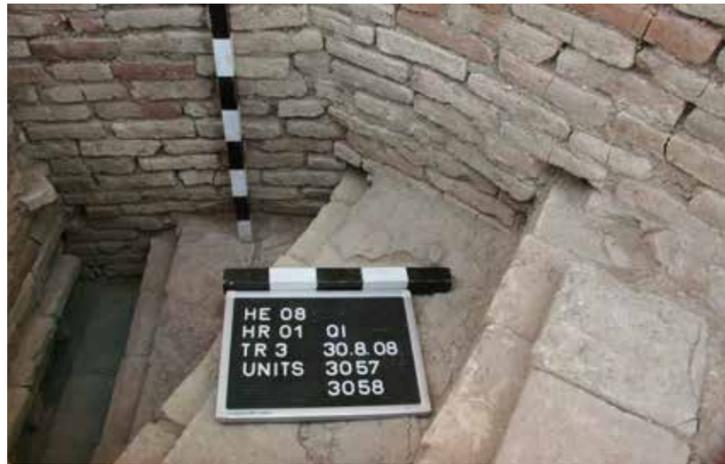
Fig. 390 Edges of the steps with recesses for supporting square timber; from north

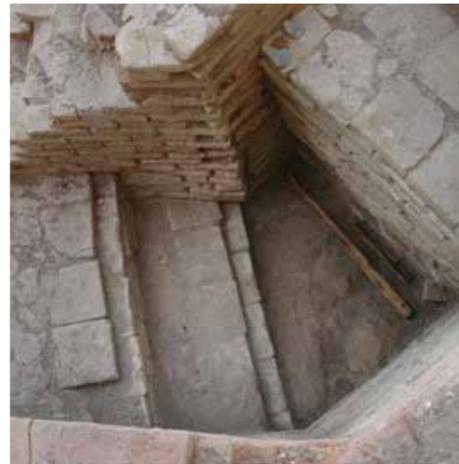
Fig. 391 Side entrance blocked by brick wall, edges of the steps originally stabilised by square timber

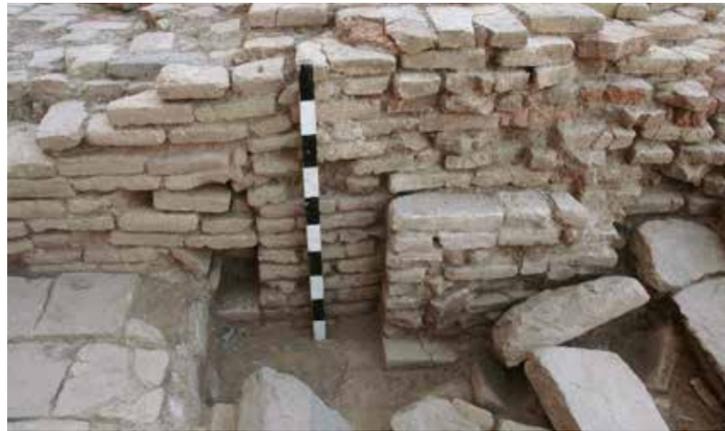
Fig. 392 Edges of the steps with recesses for supporting square timber; from east

A further detail of the use of timbers in the otherwise largely homogeneous brick construction is the reinforcement of the stair nosings with timbers. This technique was applied on a small scale with 4–5 cm broad square timbers on the staircases of the towers (Figs. 357; 395), the staircase in the upper side entrance (Figs. 390; 391) as well as on a larger scale on the broad path along the central axis in the northern central room (Figs. 392; 393; 433–435).

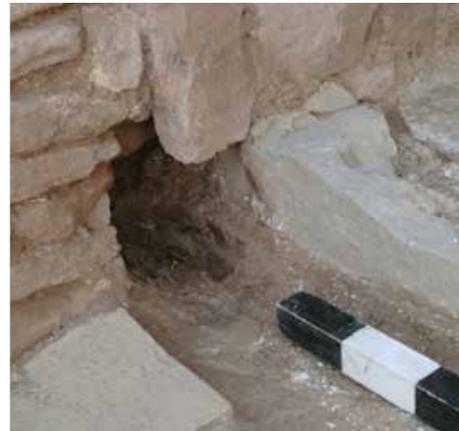
Fig. 393 Central entrance room (Room 1), lateral recesses for square timbers to stabilise the steps

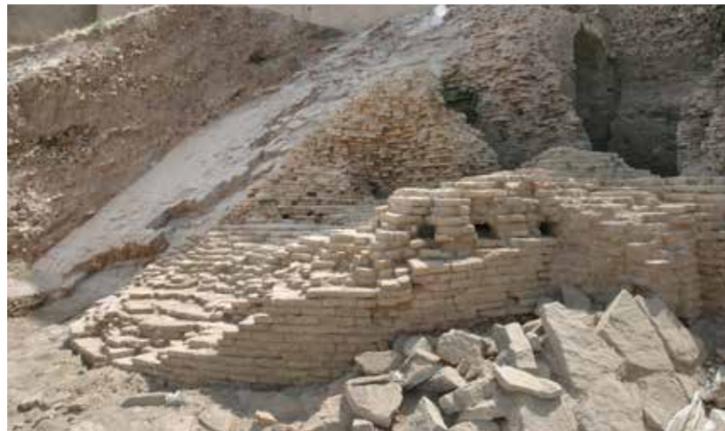
Fig. 394 Eastern tower, recesses for foundation beams; from west

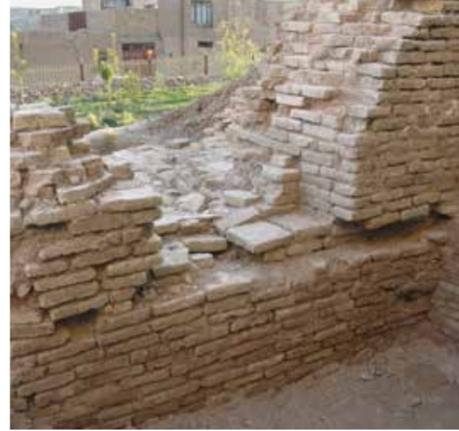
Fig. 395 Eastern tower, access from Room 3, recesses for square timbers to stabilise the stairs

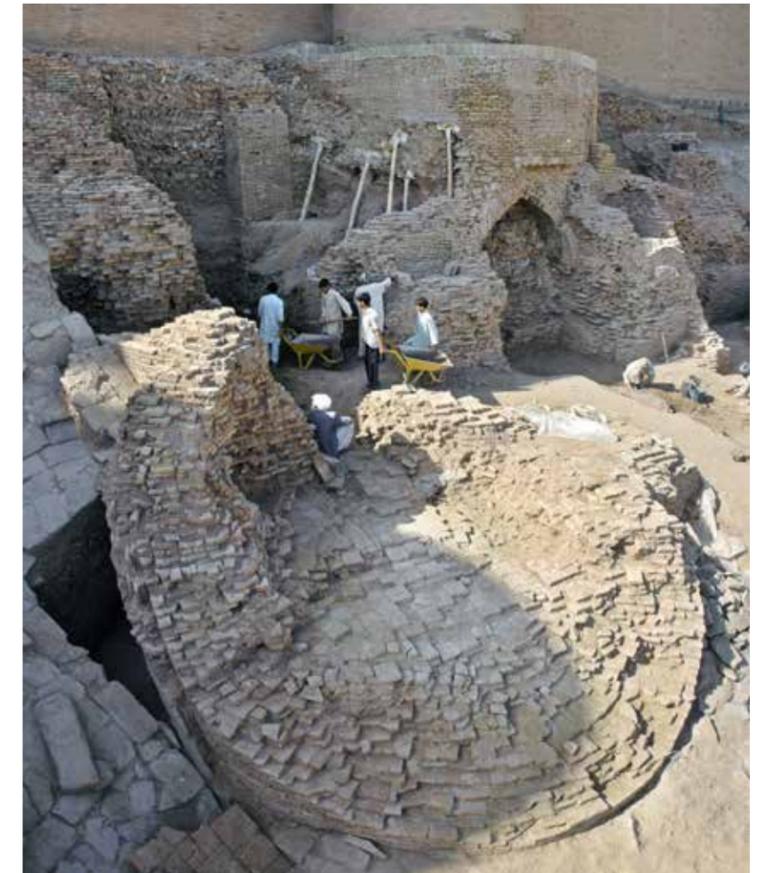
Fig. 396 Eastern tower, general view from northeast; assembled photo

The eastern tower (Figs. 394–400) is built of square bricks set in mud mortar, aligned in circular courses. The tower measures 6.70 m in diameter. Only the southeastern part of the 1 m-wide outer wall is preserved to a height of 2 m (Fig. 396), whereas in the north, following the gradient of the slope, the wall remains are just a few brick courses high.<sup>5</sup>

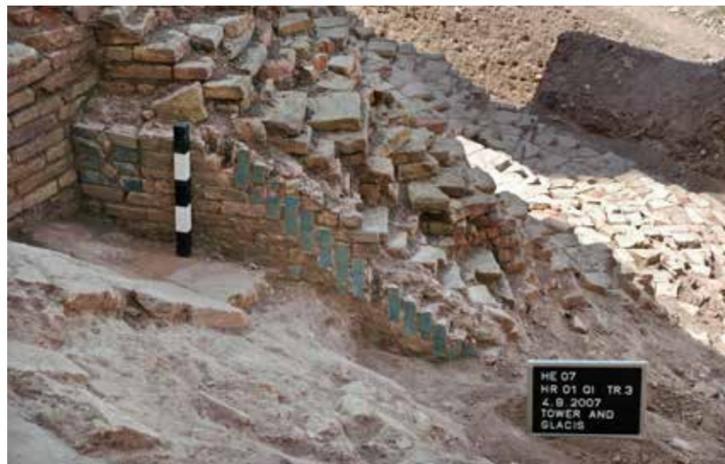
Fig. 397 Eastern tower, decoration with coloured glazed bricks in situ (detail); from east

The eastern tower is remarkable in many respects: especially important is the façade-facing with glazed bricks and a sandstone frieze, whose coherence is still preserved to great extent on the eastern facade (Figs. 321; 322; 397–400). The largest continuous area with original coloured glazed brick decoration is near the spandrel between the eastern tower and the outer wall of the gate complex (Figs. 321; 397–400). Another extensive part is today covered by the glacis that rests upon the onset of the tower. Here, the brick decoration was overlapped by heaps of earth that accumulated during the construction of the glacis and, thus, was protected for centuries' time.

Above the mantle of square sandstone slabs and the following three-layer dog-teeth frieze made of halved bricks or brick fragments (Figs. 321; 322; 397–400) are coloured glazed bricks that together compose polychrome geometric ornaments and vertical rows. Small

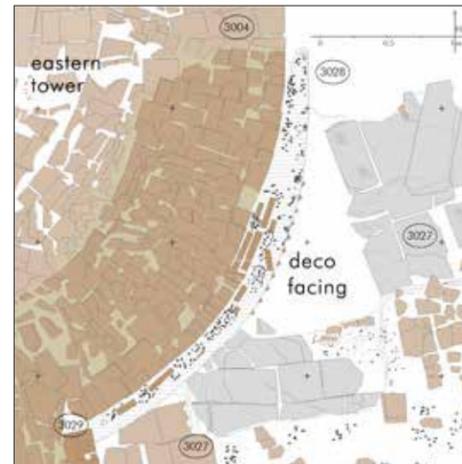
Fig. 398 Eastern tower, groundplan (detail) showing the structure of the decoration

The decorative facing was applied around the tower in a 18 to 20 cm thick sheath of horizontally and vertically set square bricks (Fig. 398), which caused the diameter of the tower to increase to more than 7 m. While the masonry of the tower shows the exclusive use of mud mortar, lime mortar was used for the facing. Thereby the construction of the decorative layer became more stable, and at the same time the masonry was protected from moisture and rain.

The decorative sheathing concurs in its thickness with that of the tower's outer wall, which shows a recess the size of approx. half a brick (Fig. 398). This is of special importance for the chronological identification of the tower's ornamentation, because this slight recess could have been realised only with the knowledge that this irregularity would be equalised eventually by the decorative sheathing. The tower and the decoration were thus built in one and the same constructional measure.

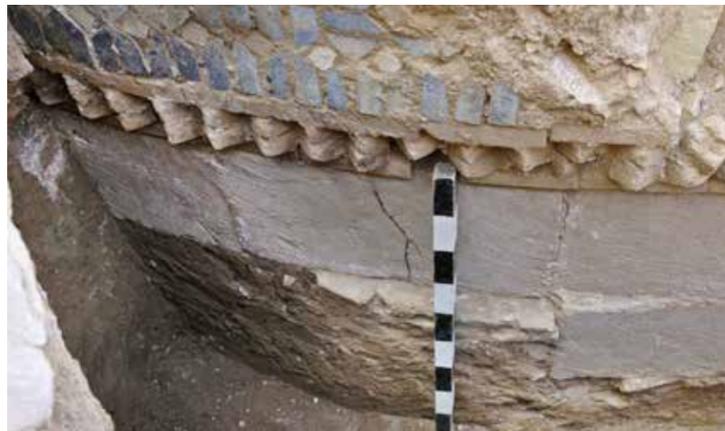
Fig. 399 Eastern tower, coloured glazed bricks, dog-teeth frieze and sandstone slabs in situ; from east

square white-glazed bricks are equally part of that ornament of light blue and dark blue rectangular formats, some of them also with one bevelled narrow side (Fig. 399).

Discernible from the sandstone facing of the eastern tower are the position and the original gradient of the citadel slope (Figs. 399; 400). The sandstone slabs are stepped towards the hillside, with additional bricks laid to compensate for the inclining surface of the slope.

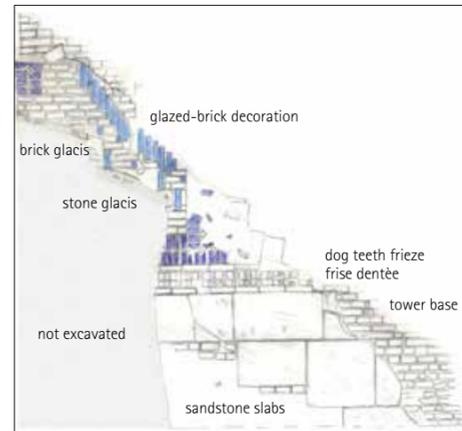
Fig. 400 Eastern tower, decoration elements of the façade, developed drawing (detail)

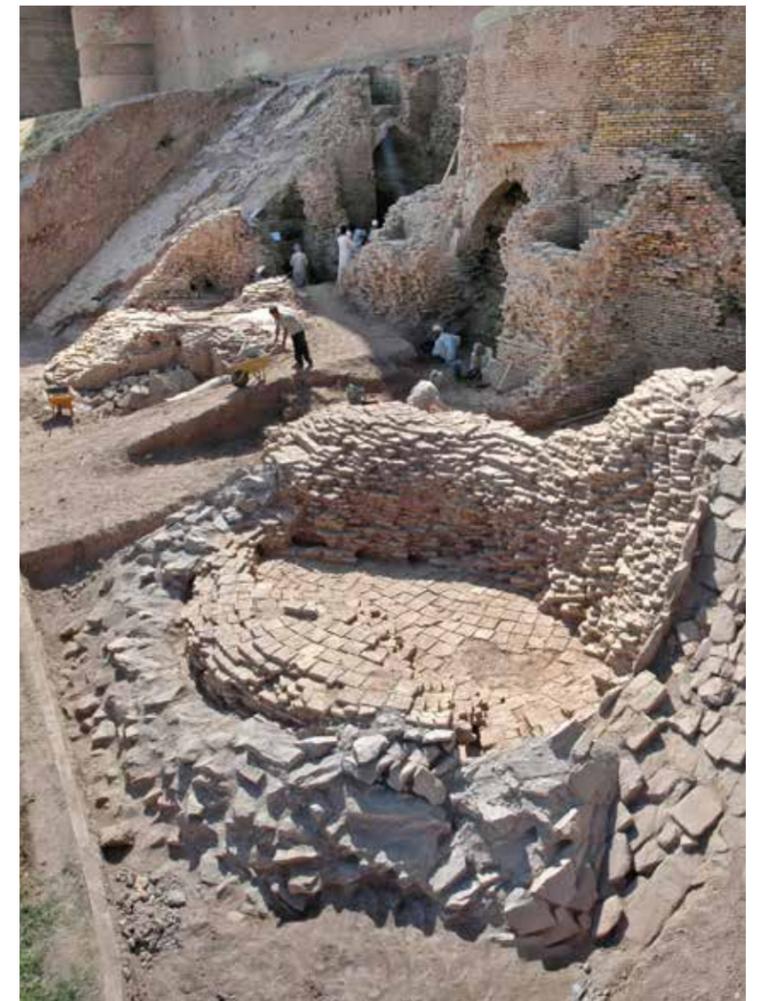
Fig. 401 Western tower, general view from west

Part of the western tower was unearthed for the first time in 1980 (Fig. 308); in 2008 it could be completely excavated (Fig. 401).
